M.A. Dissertation 2007

Conservation of Wall Painting Dept.

Courtauld Institute of Art

An Investigation of Chemical Methods for the Removal of Aerosol Graffiti Paint from Contemporary, Exterior Mural Paintings

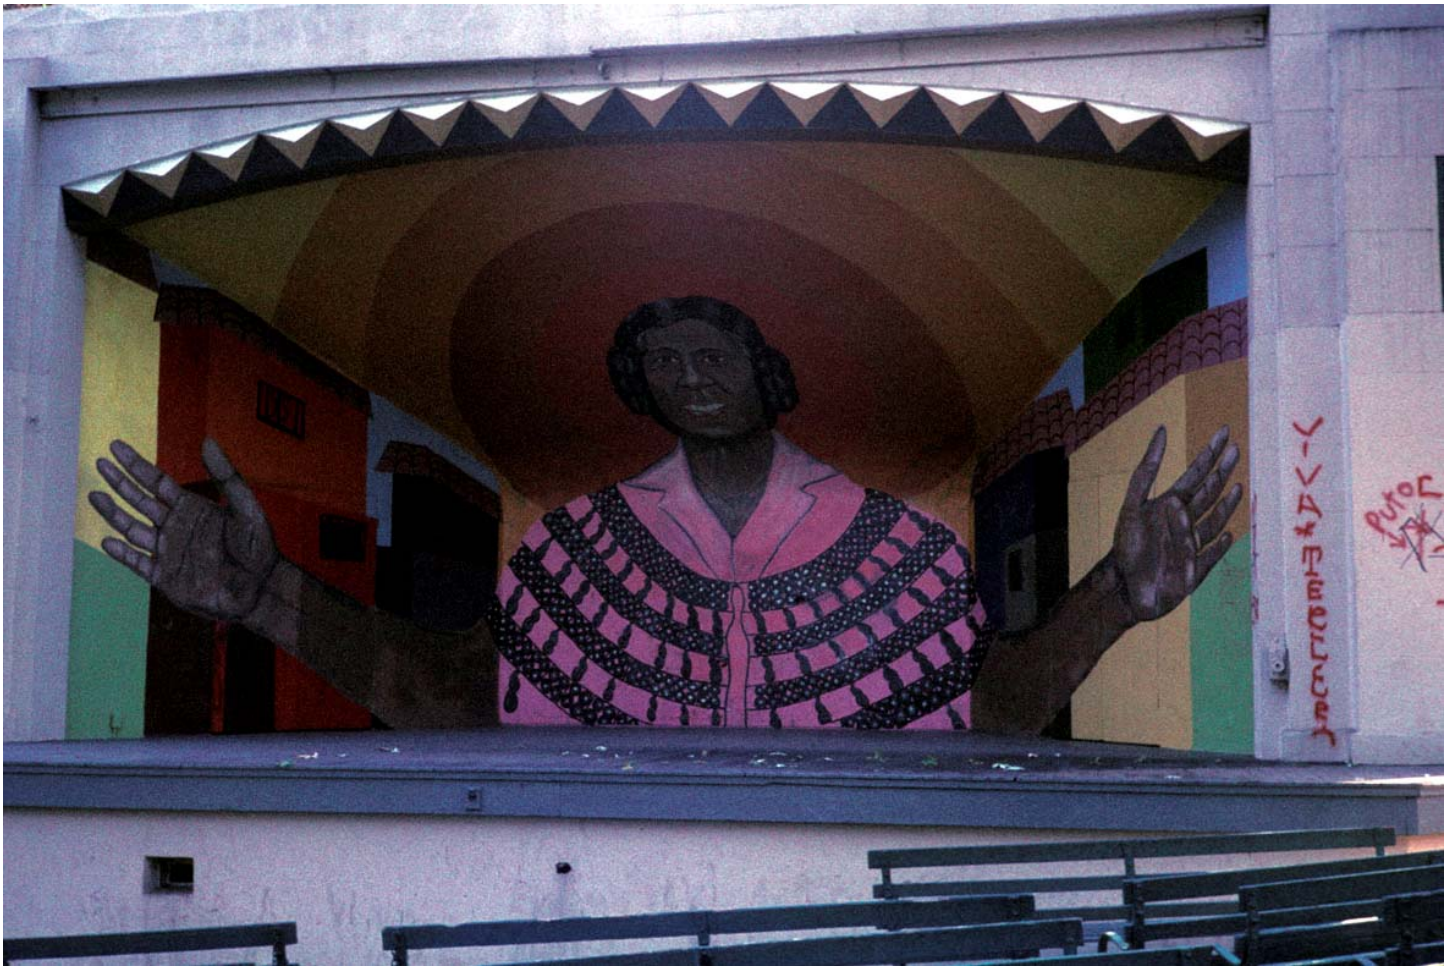
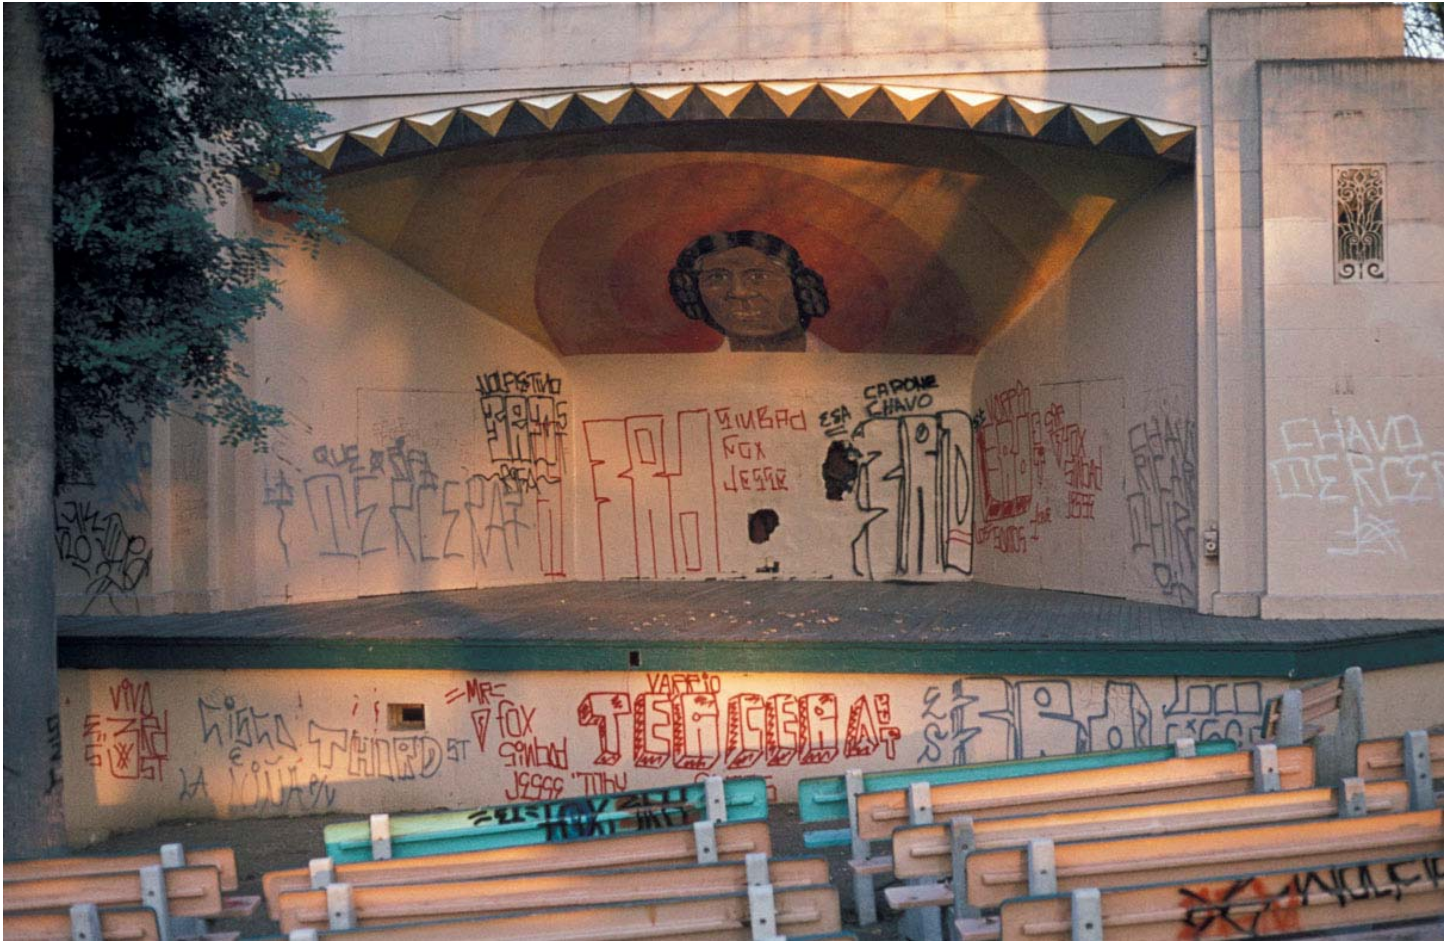
Figures 1.16 (above) and 1.17 (below): 'Title', date and artist unknown, located on the interior of the bandstand at McArthur Park in Downtown Los Angeles, California. The image above depicts the mural as it appeared when it was first painted and in good condition, while the image below depicts the same mural at a later date. In the lower image, the vast majority of the mural has been painted out with a solid layer of paint due to repeated attacks of graffiti vandalism. **Photos: E. Long 1973 (above) and 1980 (below).**

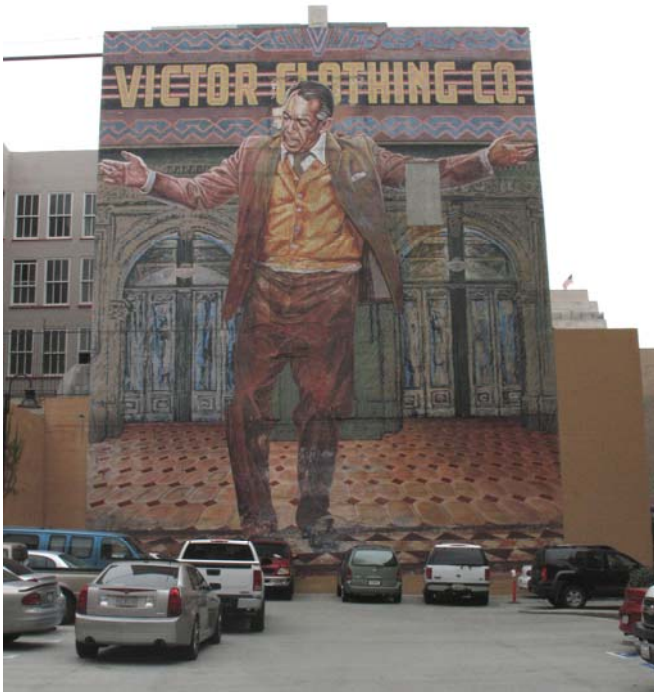
Figures I.19 (above) and I.20 (left): Torrez's mural has suffered from graffiti attacks and subsequent cleaning attempts which have left the lower portion of the original paint layer severely damaged and muddled (above). The damage is particularly evident when the lower section of the painting is compared to a detail of the upper section which graffiti has not affected (left). **Photos: Courtauld Institute CWPD 2007.**

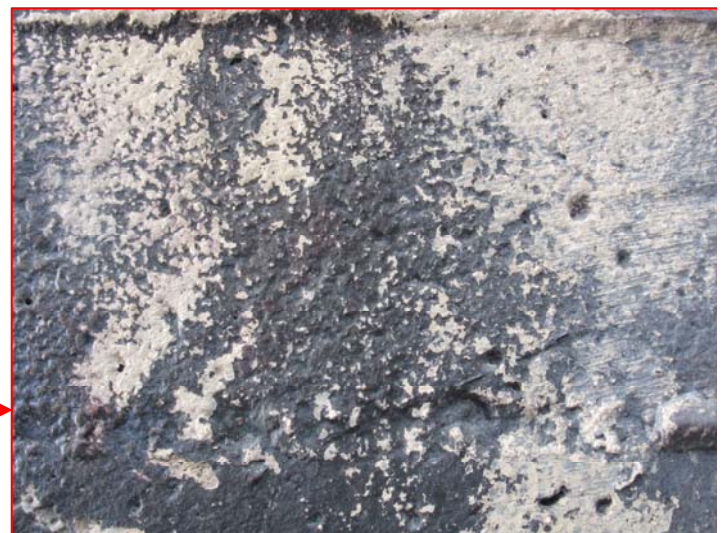
Figures I.21 (above left) and I.22 (above right): Detail of the damage caused to the original paint layer by a poorly implemented attempt at graffiti removal. **Photos: Courtauld Institute CWPD 2007.**

- *Cleaning* – Graffiti removal may be undertaken by either a conservator or a non-specialist. However, in either case it is most often undertaken with the use of proprietary graffiti removal products (Rainer *et al.* 2002: 110) which often cause severe damage to the original painting (Figures 1.18 to 1.22).

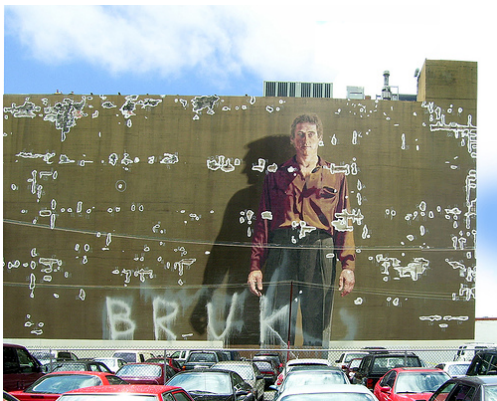
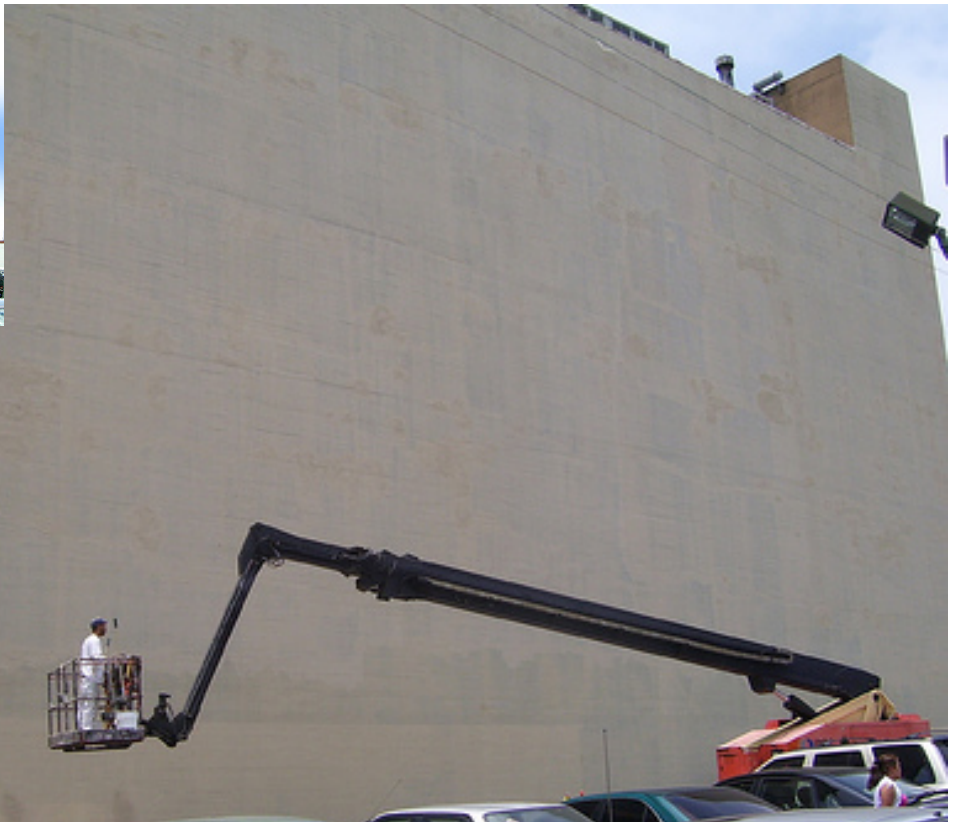
Figures I.24 (above left) and I.25 (above right): The two images show the mural, 'Ed Ruscha Monument', as it appeared a few months prior to being painted out in June of 2006 (above left) and as it appears currently (above right). **Photos: P. Schmelzer 2006.**

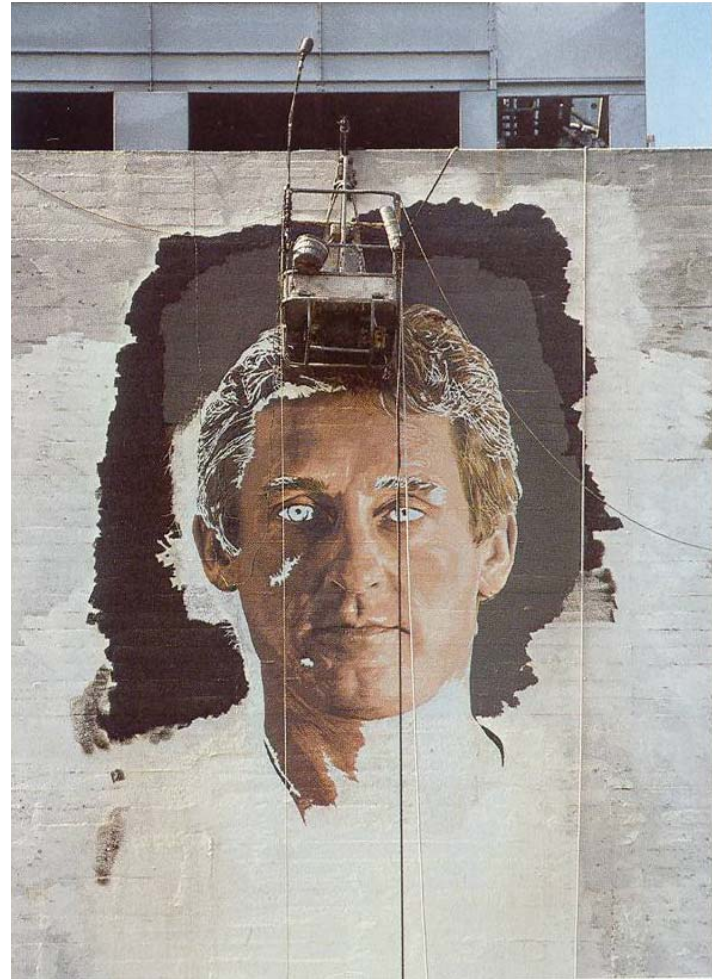
Figures 2.10 (above left) and 2.11 (above right): 'Ed Ruscha Monument' by Kent Twitchell, 1978-87, located on S. Hill St in Los Angeles, California. The above images depict Twitchell's mural prior to completion. It is possible to see the white layer of acrylic gesso which Twitchell, like most artists, used to prepare the wall surface for painting **Photo: V. Barthelmeh 1981.**

Surface preparation for contemporary murals is often minimal but generally consists of superficial cleaning of the support, which will often have been in existence for years prior to the creation of a painting on it. A solid base layer of light-coloured paint or acrylic 'gesso' is then commonly applied to the support or render to prepare the surface for painting (*Figures 2.10 and 2.11*). Acrylic gesso is a modern synthetic version of the traditional gesso priming material which was composed of powdered gypsum (or occasionally calcium carbonate) in an animal glue binder. Today the modern material is created from a mixture of calcium carbonate and pigment (often titanium dioxide) in an acrylic polymer medium ([wikipedia.org/Gesso 2007](http://wikipedia.org/Gesso)).

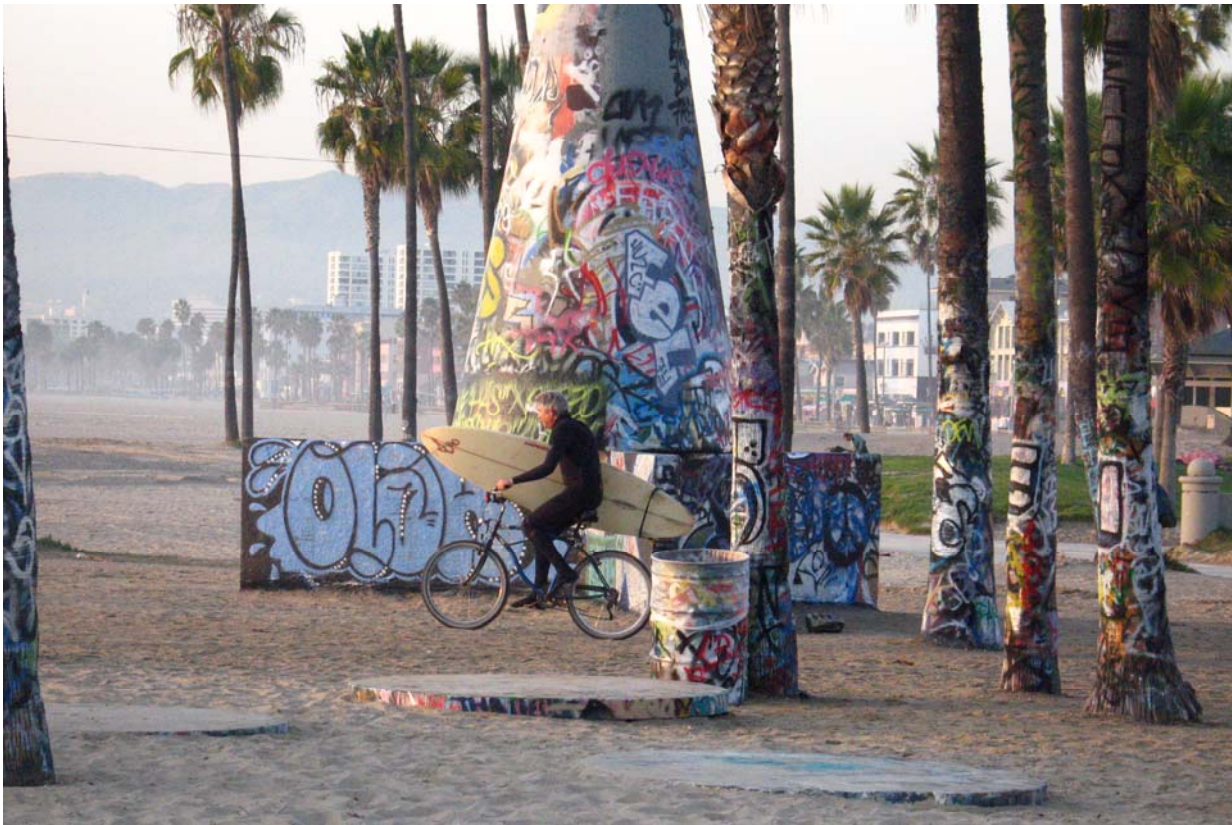
Figure 3.1: Venice Beach, California. The variety in color and finish which can be achieved and the fact that there is no limitation of surfaces to which aerosol paints can be applied make them an extremely popular media amongst graffiti artists. **Photo: Courtauld Institute CWPD 2006.**

- There are no limitations of surfaces to which they can be applied (*Figure 3.1*)
- A large surface area can be covered rapidly
- The intensity and thickness of the marks produced can be easily altered by switching nozzle types on the spray can
- Drying time is extremely short, which reduces the chances of removal before setting
- The paints are available in an incredibly wide range of colours and finishes, aiding in visibility and individuality of the markings
- An extensive range of paint compositions are available, increasing the chances of resistance to chemical removal agents

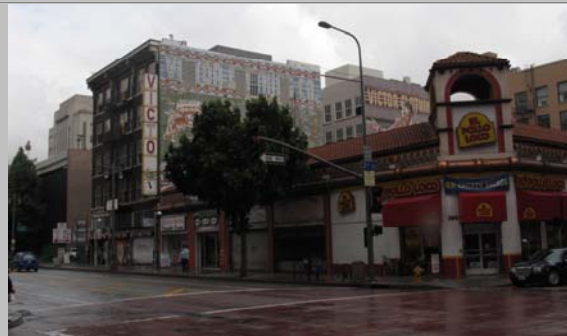
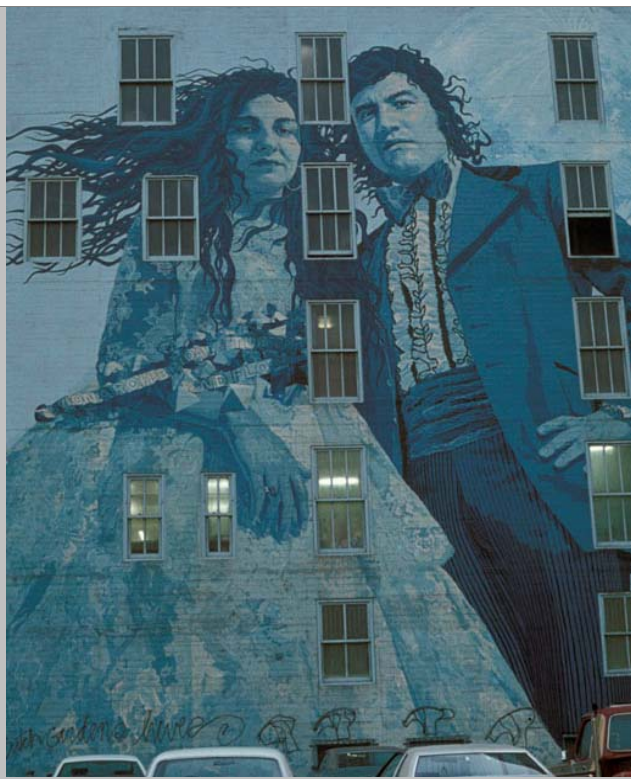
Photo: Courtauld Institute CWPD 2007

Title: The Bride and Groom
Artist: Kent Twitchell
Designated Case Reference no.: 102
Size: 70 x 70 ft.
Date: 1972 - 1976
Subject Matter: The mural, painted in a monochromatic palette, depicts a larger-than-life, photo-realistic image of a Latino couple clothed in wedding attire (Dunitz 1993: 36). The male figure is a portrait of Carlos Ortiz, former owner of a 2 nd floor bridal shop in the Victor Clothing Co. building (Maese 2007).

Condition: The mural is in a generally good condition. Although covered by layers of graffiti paint in the lower section (*Figure 10.10*), the original paint layer is sound. Some cracking and flaking of the paint layer is apparent, however this deterioration is not extensive and appears to be related to cracking or deterioration of the cement support (*Appendix 4.2.3*).

Added Materials: A protective coating of Nova Color gel medium was applied to the lower section of the painting in the late 1970s (PC Twitchell 2007). The medium is rather soft and wax-like, and therefore attracts smog and dirt. It furthermore appears to have contracted over time, producing a network of fine vertical cracks which expose the original paint surface beneath (*Figures 10.12 and 10.13*). The surface has subsequently been heavily tagged with both aerosol and brush paint, creating a thick layer of graffiti on top of the deteriorated coating.

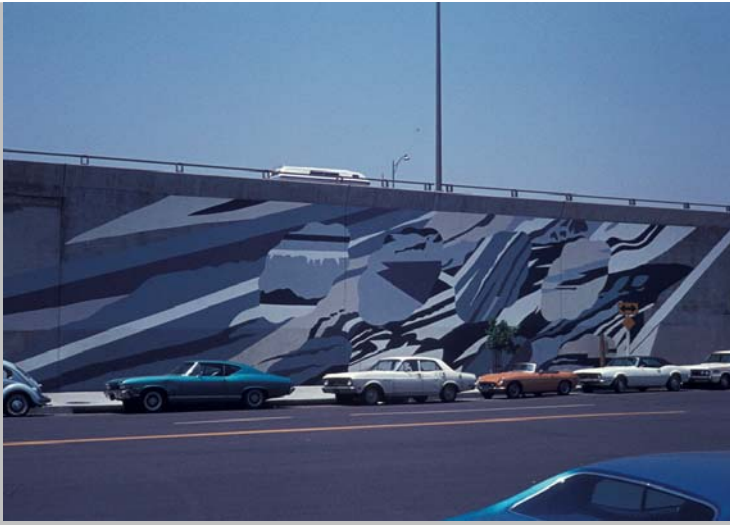
<p><i>Photo:</i> E. Long 1974</p>	
<p><i>Subject Matter:</i> The mural depicts an abstract diagram of a system of interactions between freeway and pedestrian traffic. It is painted in tonal variations of gray and based on a series of the artist’s canvases (Dunitz 1993: 35).</p>	
<p><i>Physical Context:</i> The painting is situated on the northeast retaining wall of the I 10 freeway at 1st Street in Downtown Los Angeles. The site is owned by Caltrans and the mural therefore falls under their jurisdiction (Appendices 4.3.2 and 4.3.4).</p>	
<p><i>Significance:</i> Flow Inversion was painted as part of The Inner City Mural Program, the first government-sponsored mural program in Los Angeles, which commissioned twenty murals between June 1, 1973 and May 31, 1974 (Severall 2000).</p>

<p><i>Condition:</i> The mural shows a good deal of hairline cracking which appears to be caused by similar cracking in the support. Some peeling of the paint layer is evident (Figures 10.49 and 10.50) but in general the paint layer is coherent and stable (Appendix 4.3.3).</p>	
<p><i>Added Materials:</i> The painting is reportedly covered by a non-original anti-graffiti (AG) coating (Appendix 4.3.9) which is visible when a layer of superficial deposition is removed from the painting surface. The coating is recorded as ‘waxed-based’, however is not embedded with dirt particles. The painting has been heavily tagged with both aerosol and brush paint, creating a thick layer of graffiti on top of the coating. Intermittent repainting of the lower 8 feet of the mural is reported to have taken place in 1994 however graffiti now covers any evidence of this (Appendix 4.3.9).</p>	
<p><i>Available Documentation:</i> LA City Cultural Affairs Department report (Appendix 4.3.9)</p>

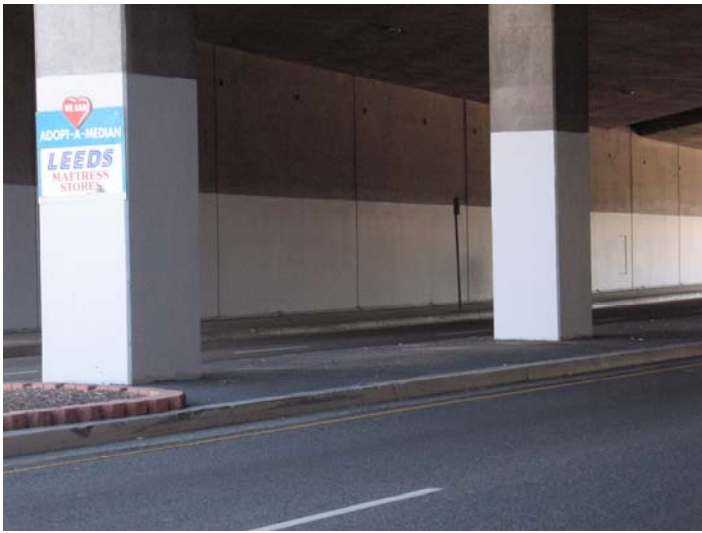
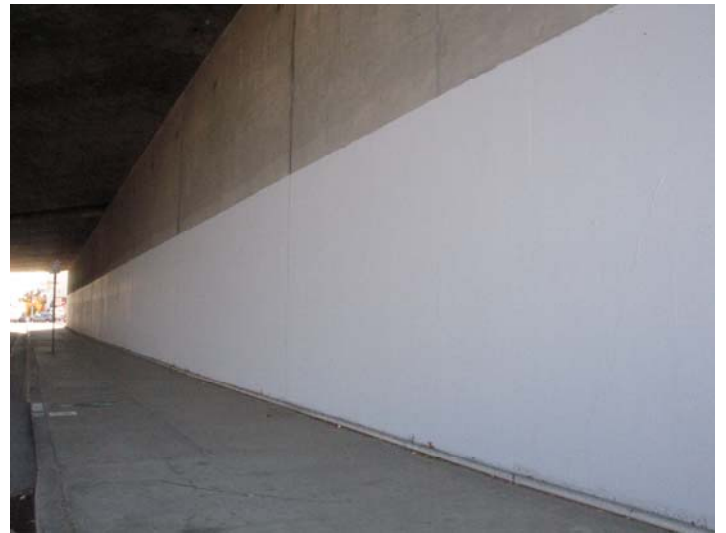
Figures 7.1 (left) and 7.2 (right): Upon initial inspection of the murals which had been short-listed for on-site evaluation, a number were found to have been painted out or otherwise destroyed since last recorded. A mural which at one time stretched the entire length of either side of the underpass pictured was encountered in the above state, appearing to have been painted out quite recently. **Photos: Courtauld Institute CWPD 2006.**

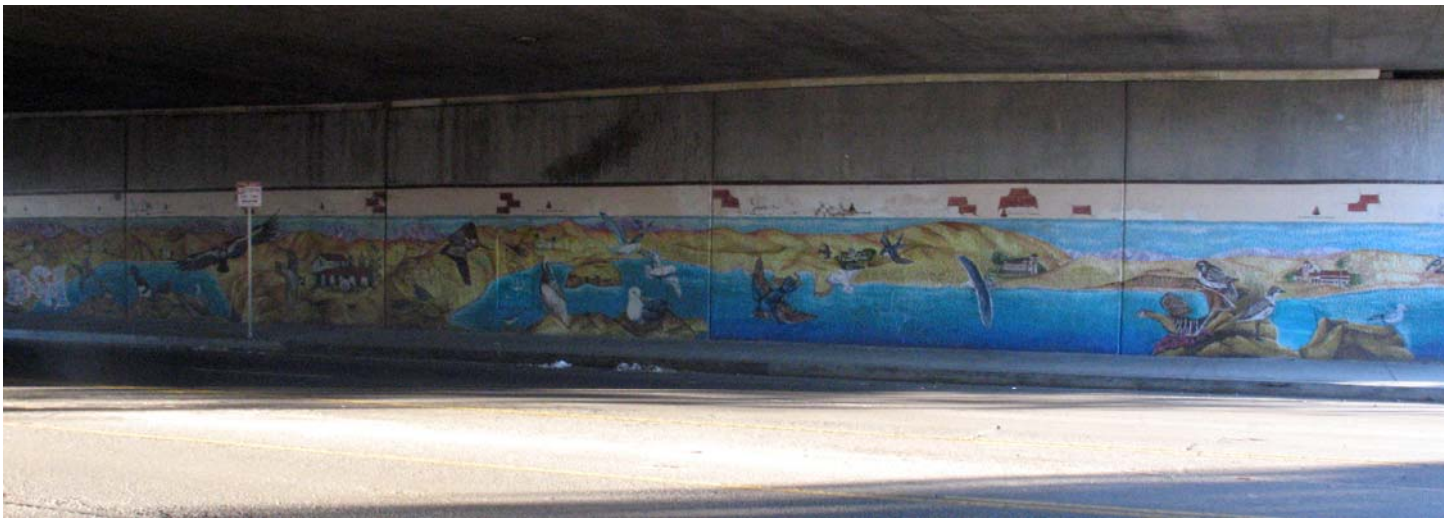
Figure 7.3: 'Los Pajaros de California' by Michelle Obregon and Candace Ocampo, 1996-97, located on Van Nuys, 405 underpass in Los Angeles, California. **Photo: Courtauld Institute CWPD 2006.**

Case study selection was restricted to murals executed primarily with acrylic paint materials to ensure that cleaning issues among case studies remained as comparable as possible. Furthermore, only paintings on cement supports were considered, again to minimize project variables and as this was a primary requirement for colleague Kiernan Graves. Finally, it was useful to avoid *stucco* and other heavily textured surfaces if possible as this would again complicate the cleaning trials (*Figures 7.3 and 7.4*).

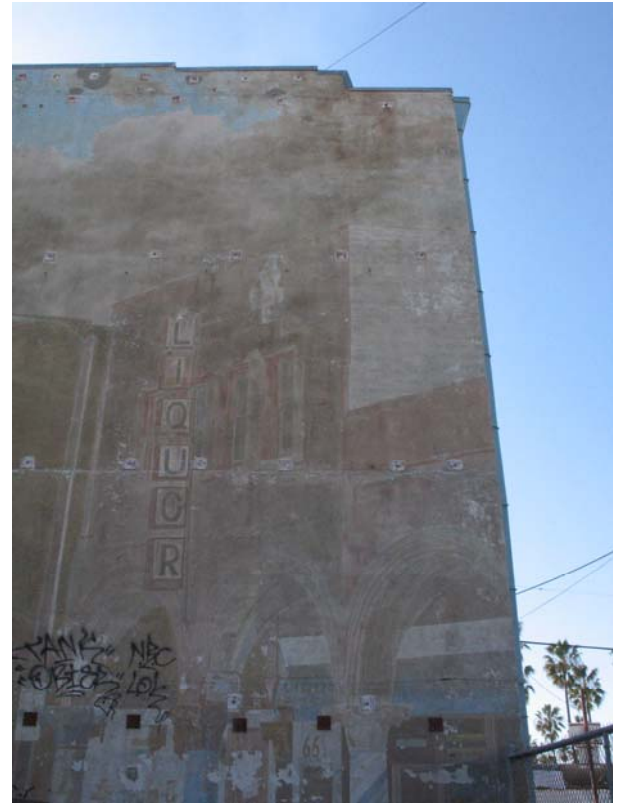
Figures 7.6 (above): 'St Charles Painting' as it appears today. The surface is defaced by only one scrawling tag. **Photo: Courtauld Institute CWPD 2006.**

Perhaps most significantly, case studies selected had to be covered with a considerable amount of aerosol graffiti material (*Figures 7.5 to 7.9*). The graffiti had to be extensive in order to provide a comprehensive range of conditions and locations for removal trials.

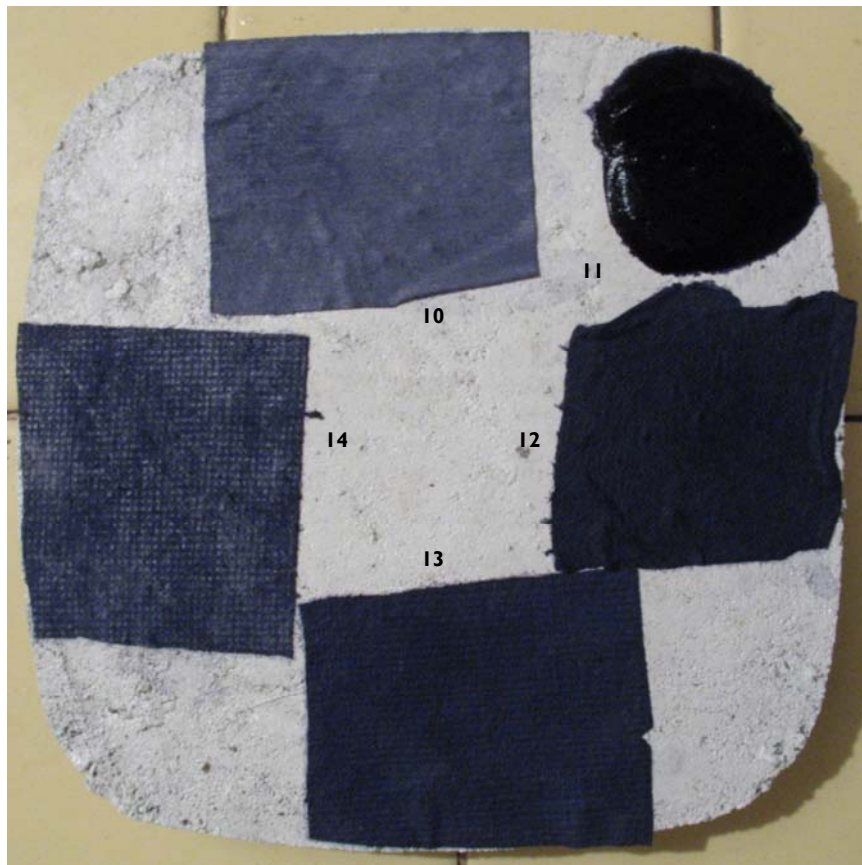
Figures 10.1 (below left) and 10.2 (below right): The images below depict the results of preliminary, ex-situ testing of sorbent materials. **Photos: Courtauld Institute CWPD 2007**

01. Arbocel BC200; 02. Arbocel BWW40; 03. Arbocel B800; 04. Klucel PR; 05. Dicalite SA3; 06. Sepiolite; 07. Pansil 400; 08. Pangel S15; 09. Pangel S9; 10. Contec C2; 11. Carbogel 2%; 12. WypALL L30; 13. WypALL X70; 14. WypALL X60.

The sixteen sorbent materials initially assessed were subjected to preliminary, *ex-situ* testing (Figures 10.1 and 10.2) (see Appendix 2.1). Based on the results of testing, ten materials were eliminated while only 6 were retained for further use.

Klucel PR	Extremely difficult to prepare for use.	Eliminated
Benecel M-043	Extremely difficult to prepare for use.	Eliminated
WypALL X60	Poor adhesion to acrylic paint surface.	Eliminated
WypALL X70	Good results	Retained
WypALL L30	Difficult to manipulate when wet and poor adhesion to acrylic paint surface.	Eliminated
Contec C2	Good results	Retained
Whatman blotting paper	Poor conformance to surface observed.	Eliminated

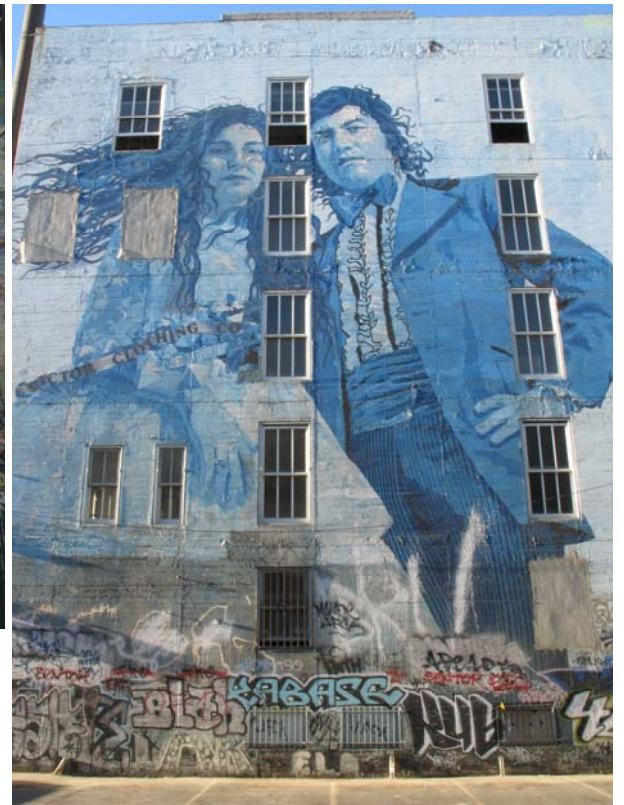
Figure 10.10: 'The Bride and Groom'. Overview of the mural as it appears today with heavy graffiti paint covering the lower region. **Photo: Courtauld Institute CWPD 2007**

Solubility tests and cleaning trials on *The Bride and Groom* (Figures 10.9 and 10.10) were very much complicated by the presence of a thick coating (Figures 10.11 to 10.13). Trials aimed to achieve an overall level of homogeneity within the mural and therefore both a solvent and application methodology had to be adapted which would remove the graffiti paint without removing or thinning the coating. Doing so was an important aspect of retreatability so that if and when the coating is removed in the future, the level of removal required from area to area is uniform. Furthermore, since the re-application of a coating following trials was not a possibility, cleaned areas needed to retain their coating so that the original paint layer was not exposed to likely future acts of vandalism.

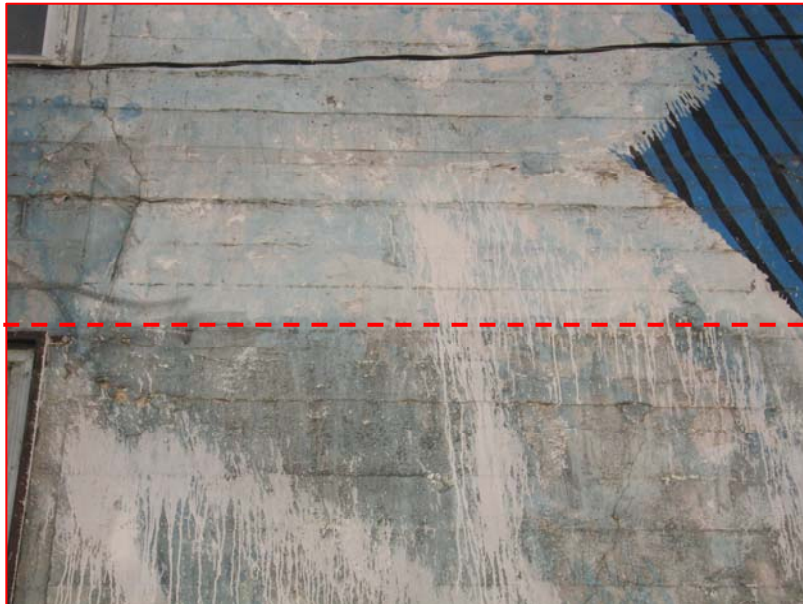
Figure 10.11 (left): The thick gel medium was applied as a coating to the lower half of the mural surface in the late 1970s to protect the surface from graffiti vandalism. Due to its low glass transition temperature the coating has attracted dirt and pollution causing a darkened appearance. **Photo: Courtauld Institute CWPD 2007**

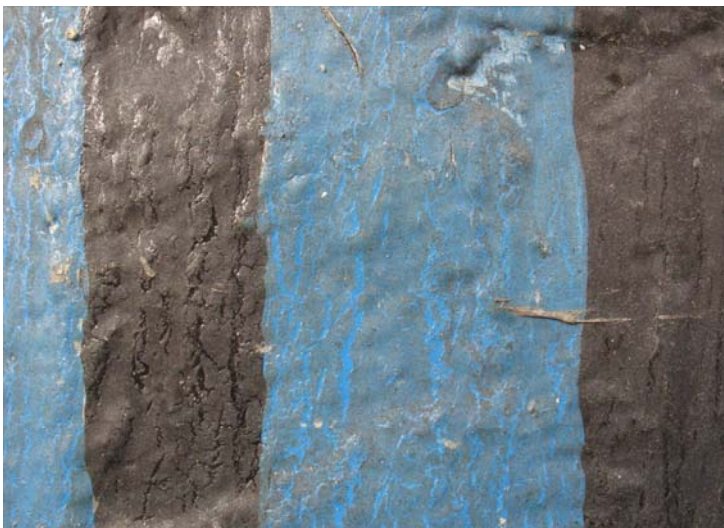
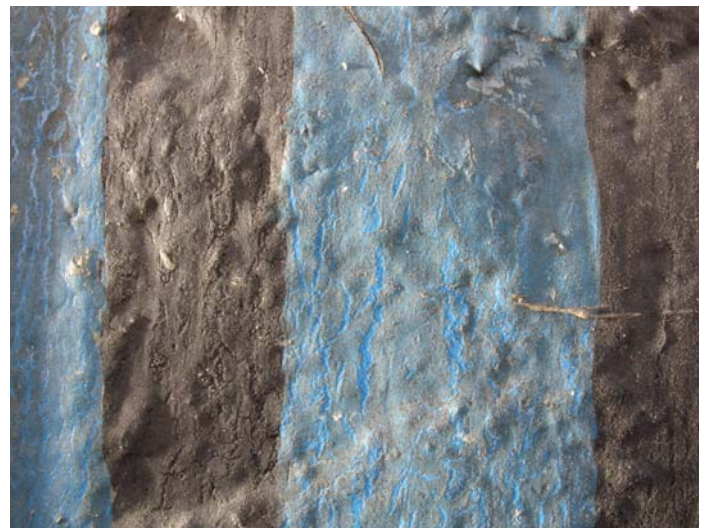
Figures 10.12 (above left) and 10.13 (above right): Macro images of the thick coating in normal (left) and raking (right) light demonstrate that it has contracted over time, producing a network of fine vertical cracks which expose the original paint surface beneath. **Photo: Courtauld Institute CWPD 2007**

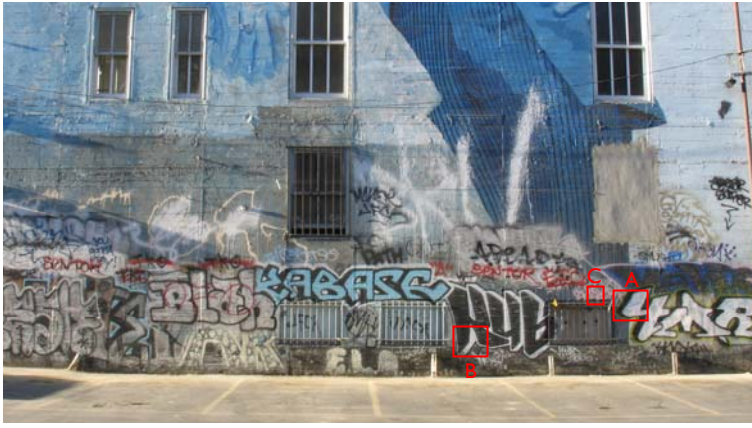
Figure 10.14: Sites of successful cleaning trials (A) 102-T.12, (B) 102-T.19, and (C) 102-T.20. **Photo: Courtauld Institute CWPD 2007**

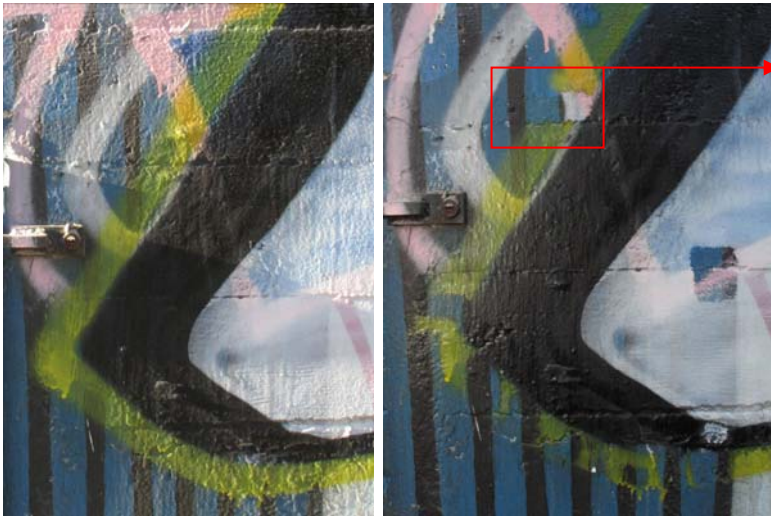
Figures 10.15 (above left) and 10.16 (above right): Site of trial 102-T.12; pre-cleaning (left) and post-cleaning (right). **Photo: Courtauld Institute CWPD 2007**

Cleaning System		Pros.	Cons.
<i>Cleaning System 1 - Trial 102-T.12 (Figures 10.15 to 10.17)</i>			
<i>Application</i>	Arbocel B800 / MP (3 min.)	- Complete removal of graffiti	- Only applicable to more soluble graffiti materials
<i>Clearance</i>	Swabbing with MPA:Stoddard Solvent (1:2)	- No thinning or damage to coating or original materials - Not excessively time consuming	- Not successful universally across painting surface
<i>Cleaning System 2 - Trial 102-T.19 (Figures 10.18 to 10.20)</i>			
<i>Application</i>	Swabbing with MPA:Stoddard Solvent:Acetone (7:14:15)	- Complete removal of graffiti - Possible minimal thinning of coating, but no damage to original materials	- Extremely time consuming - Only applicable to more soluble graffiti materials
<i>Clearance</i>	N/A	- Successful on all more soluble graffiti types	
<i>Cleaning System 3 - Trial 102-T.20 (Figures 10.21 to 10.22)</i>			
<i>Application</i>	Sponge with hot water (aprox. 60-80°C) (1 min.)	- Complete removal of graffiti - removal of both more and less soluble graffiti types	- Hotsy or other hot water washer required for large-scale treatment

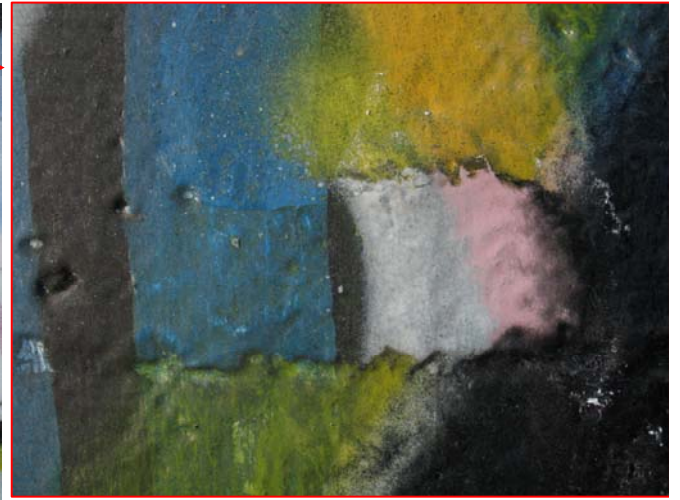
Figure 10.17: Detail; results of cleaning trial 102-T.12 showing excellent removal of the more soluble yellow and black graffiti paint but with no effect on the less soluble white and pink graffiti paints. **Photo: Courtauld Institute CWPD 2007**

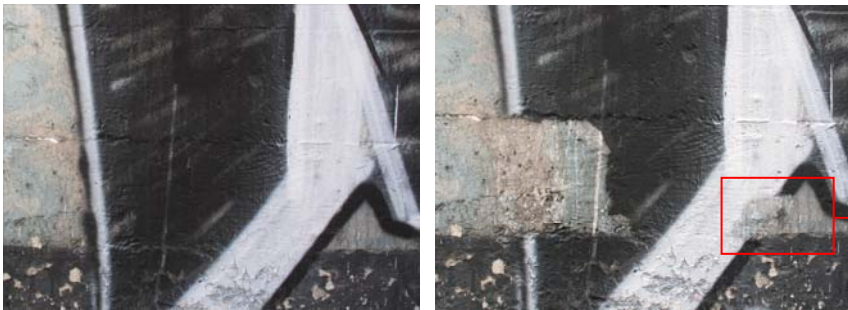
Figures 10.18 (above left) and 10.19 (above right): Site of trial 102-T.19; pre-cleaning (left) and post-cleaning (right). **Photo: Courtauld Institute CWPD 2007**

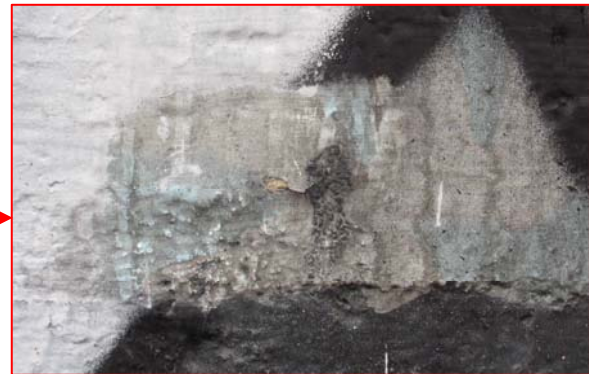
Figure 10.20: Detail; results of cleaning trial 102-T.19 on the more soluble graffiti paint. **Photo: Courtauld Institute CWPD 2007**

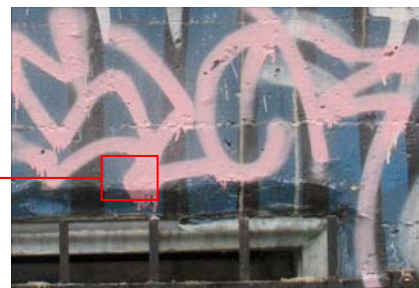
Figure 10.21 (above): Site of trial 102-T.20; pre-cleaning. **Photo: Courtauld Institute CWPD 2007**

Figure 10.22: Detail; results of cleaning trial 102-T.20 showing removal of both the coating and less soluble graffiti paint with hot water. **Photo: Courtauld Institute CWPD 2007**

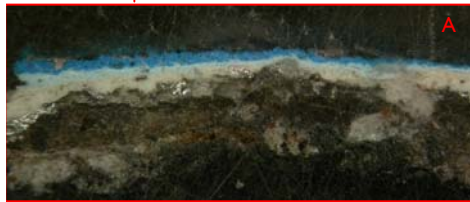
Figure 10.35: CWPD x-section 3890, photographed at 100x. **Photomicrograph:** Courtauld Institute CWPD 2007

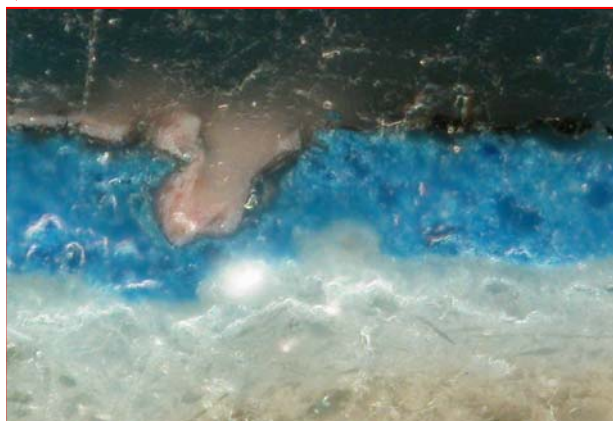
Figure 10.41: The original paint layer is shown at high magnification (500x) with coating present. **Photomicrograph:** Courtauld Institute CWPD 2007

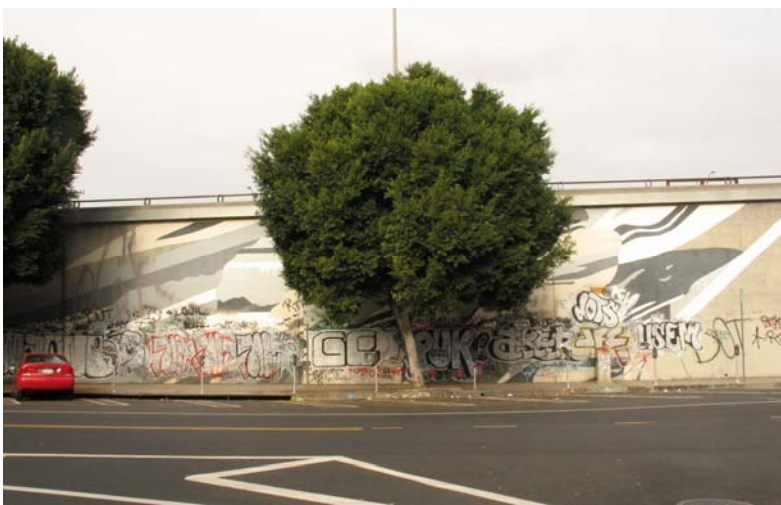
Figure 10.44: Overall view of 'Flow Inversion' in its current condition. Presently extensive graffiti paint covers the lower region of the mural. **Photo: Courtauld Institute CWPD 2007**

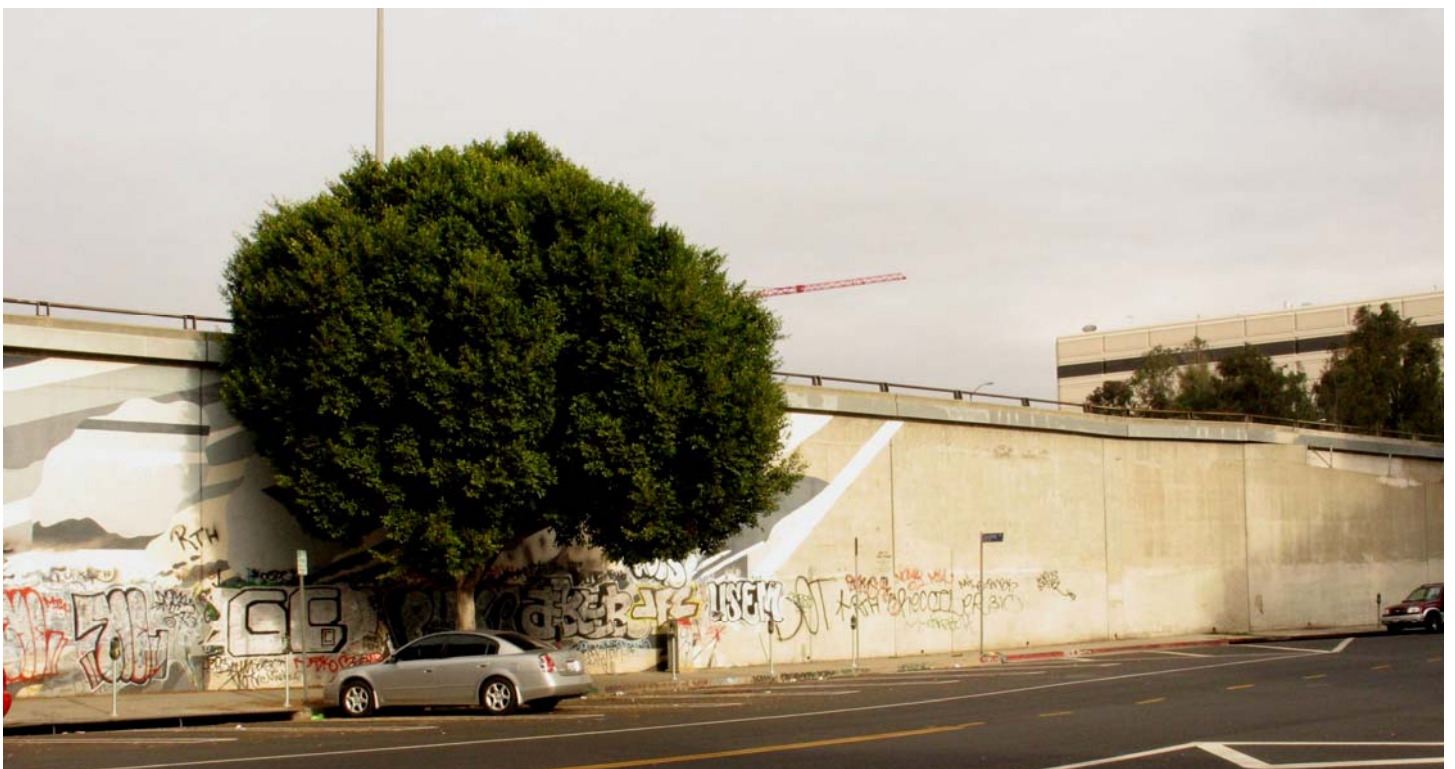
Figure 10.45: The stretch of wall adjacent to the mural painting remains un-graffitied since maintenance crews are fast to paint out any graffiti found on the blank cement wall but cannot paint over graffiti found on the mural surface. **Photo: Courtauld Institute CWPD 2007**

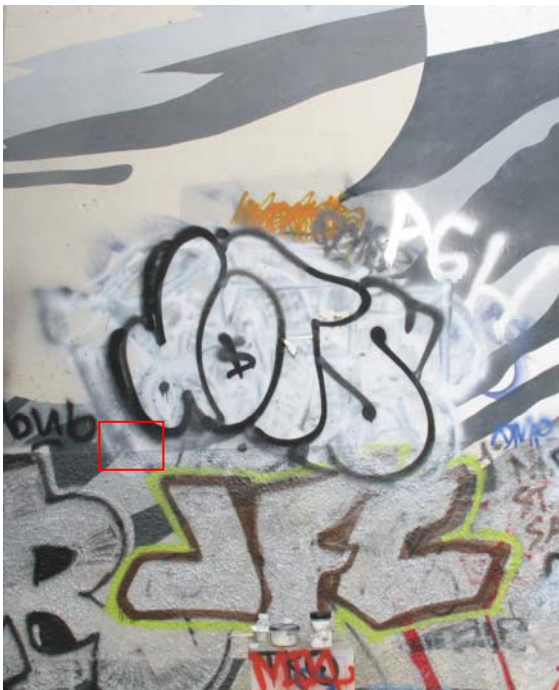
Figure 10.47: The lower third of the mural's support is covered with a highly textured, cement-based surface know as 'stucco'. The heavy texture can make it difficult to achieve a homogeneous result during cleaning. **Photo: Courtauld Institute CWPD 2007**

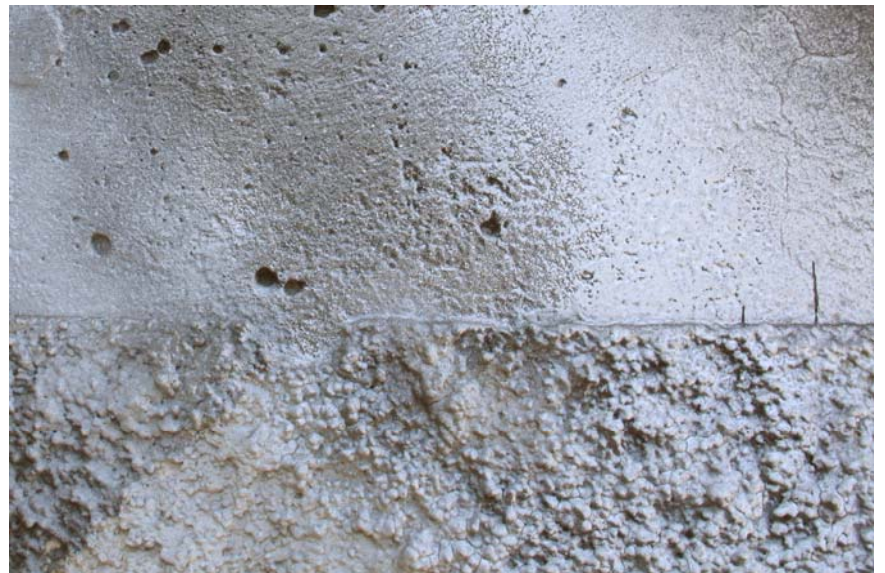
Figure 10.48: Detail of Figure 10.47 **Photo: Courtauld Institute CWPD 2007**

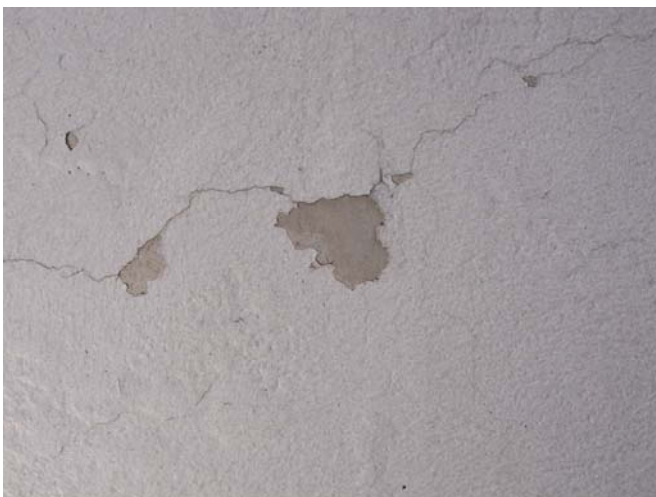
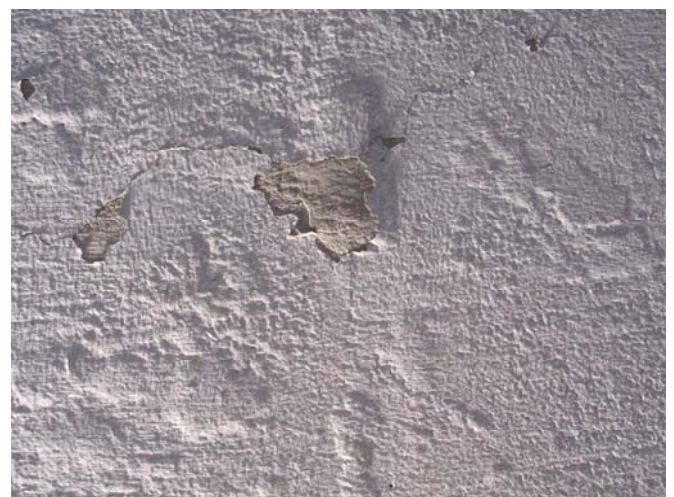
Figures 10.49 (above left) and 10.50 (above right): Although the mural displays some evidence of peeling, cracking, and blistering, the paint layer appears to be in good condition in most areas. The above figures depict an area of the original paint layer in poor condition under normal (left) and raking light (right). **Photo: Courtauld Institute CWPD 2007**

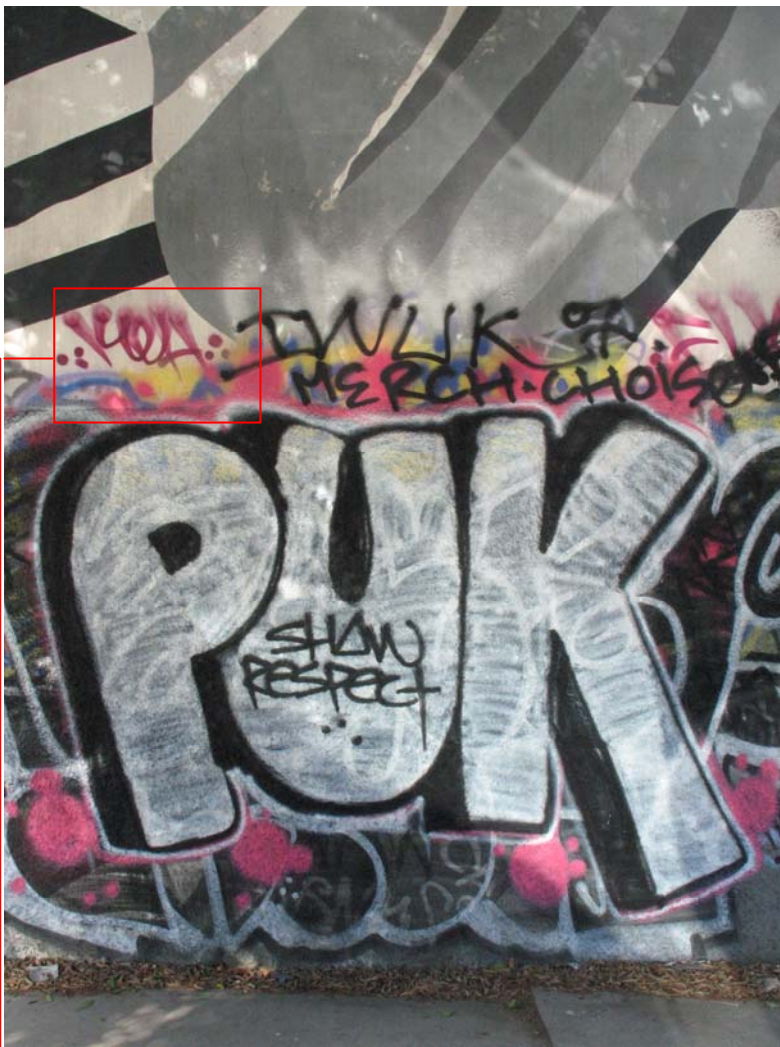
Figure 10.51: The image shows the area in which final cleaning trials were carried out. The mural surface is here depicted prior to cleaning.
Photo: Courtauld Institute CWPD 2007

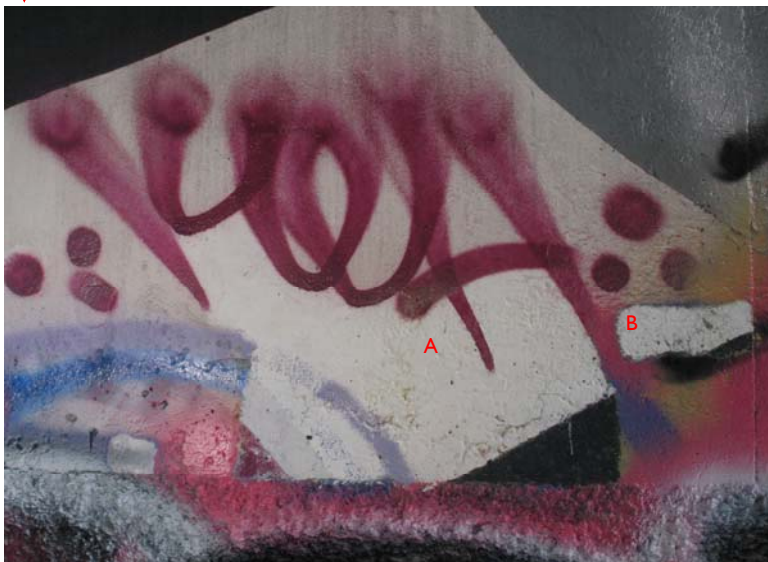
Figure 10.53: Results of final cleaning trial, (A) 104-T.21 and failed trial (B) 104-T.19. **Photo: Courtauld Institute CWPD 2007**
