M.A. Dissertation 2007

Conservation of Wall Painting Dept.

Courtauld Institute of Art

An Investigation of Chemical Methods for the Removal of Aerosol Graffiti Paint from Contemporary, Exterior Mural Paintings

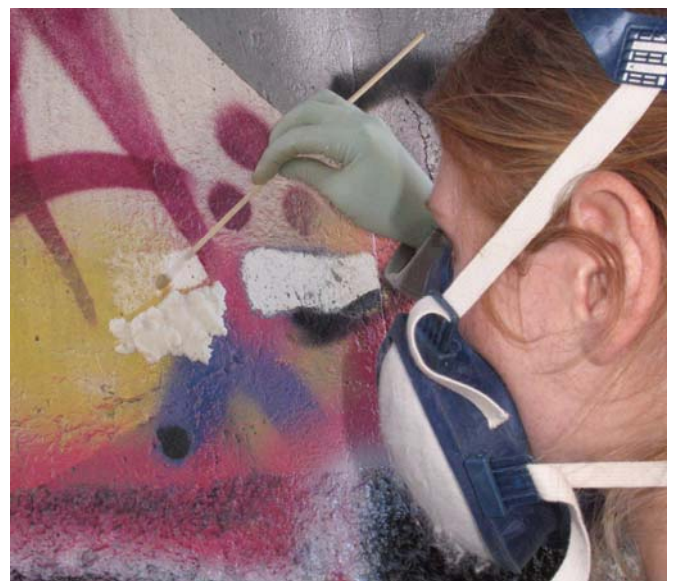
Figure 10.54: The final cleaning trial (104-T.21) was carried out with the application of a solvent mixture in Arbocel B800. The Arbocel was applied to the mural surface and could be removed section by section. In this way it was possible to avoid evaporation of the solvent from the graffiti paint before the added materials were adequately removed by swabbing with free solvent.
Photo: Courtauld Institute CWPD 2007

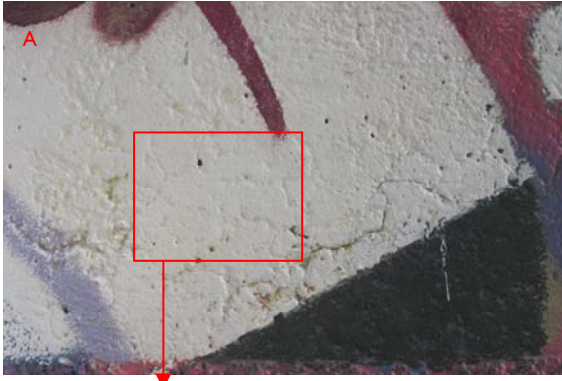
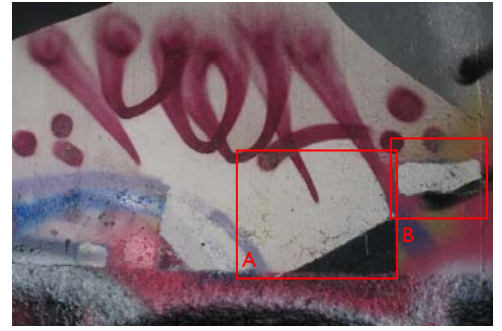
Figure 10.56 (left): Results of successful cleaning trial, 104-T.21. **Photo: Courtauld Institute CWPD 2007**

Cleaning System		Pros.	Cons.
Cleaning System I - Trial 104-T.21 (Figures 10.55 to 10.58 and 10.62 to 10.64)			
Application	Arbocel B800 / MPA:Stoddard Solvent:NMP (7:7:1) (5 min.)	- Complete removal of graffiti - No visible damage to the original paint layer - Good results achieved on both smooth and stuccoed surfaces.	- More time consuming than is ideal - Only applicable to more soluble graffiti materials - Cleaning system can be seen to swell the original paint layer to a small degree.
Clearance	Swab / MPA:Stoddard Solvent (1:1)

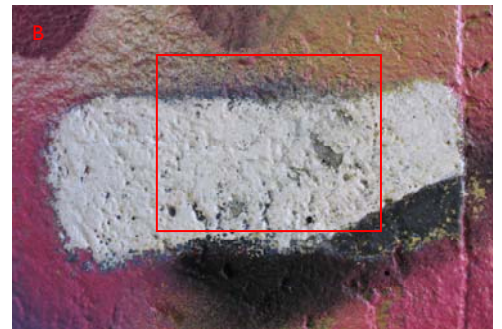
Figure 10.59 (right): Results of failed cleaning trial, 104-T.19. **Photo: Courtauld Institute CWPD 2007**

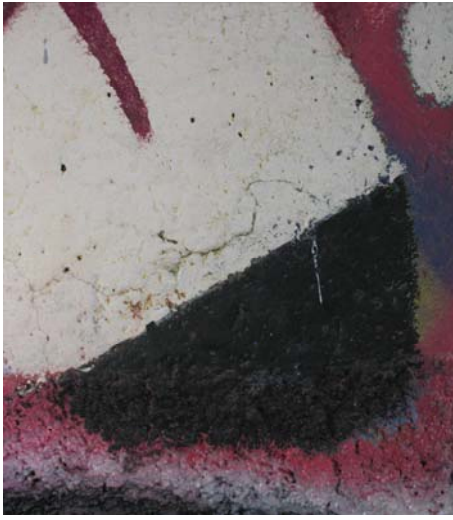
Figures 10.63 and 10.64 (right): Details of cleaning trial 104-T.21 over stucco surface in normal (top) and raking light (bottom). Slightly more graffiti paint can be seen to remain on the surface of the mural in this area but the overall results are excellent and cleaning has had no visible impact on the original paint layer. **Photo: Courtauld Institute CWPD 2007**

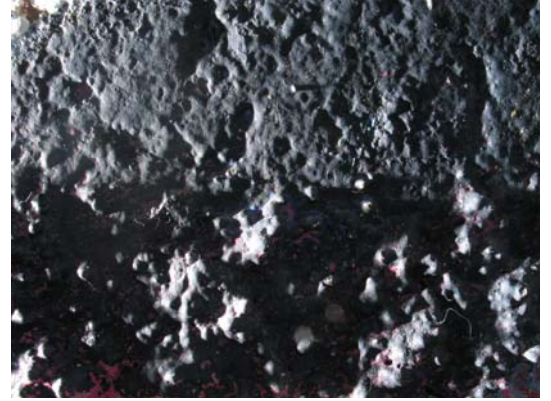
Figure 10.62: Results of cleaning trial 104-T.21, showing successful removal of the graffiti paint from the mural's stucco surface. **Photo: Courtauld Institute CWPD 2007**

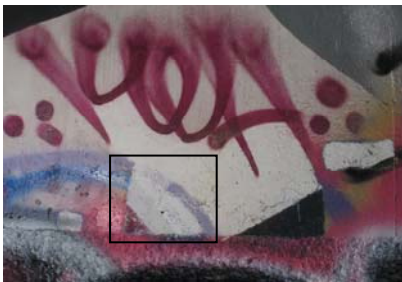
Figure 10.65 (left): Patches of the less-soluble aerosol graffiti materials were encountered beneath the more-soluble paint as cleaning was undertaken in trial 104-T.21. Unfortunately, the cleaning system implemented was unable to successfully remove this material. **Photo: Courtauld Institute CWPD 2007**

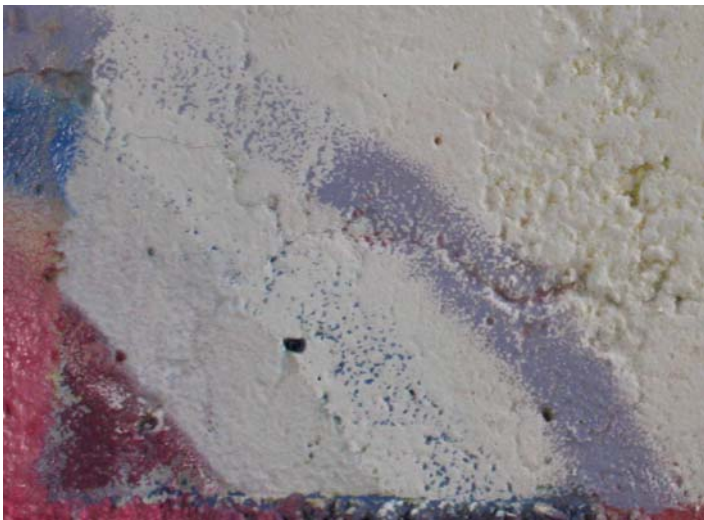
Figure 10.66 (left): Detail of Fig. 10.64. **Photo: Courtauld Institute CWPD 2007**

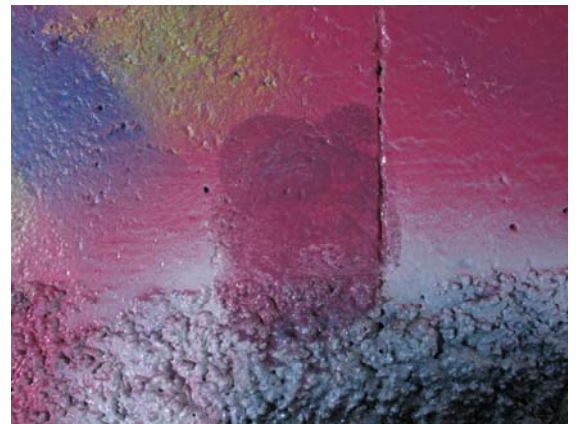
Figure 10.67 (above right): During trial 104-T.13 in which the proprietary graffiti-removal product, Graffiti Gold Remover™, was used for cleaning. **Photo: Courtauld Institute CWPD 2007**

- Since the applied sorbents failed to absorb the swollen graffiti paint layers, swabbing was the only clearance method found which would remove the dirt but was also delicate enough that it would not damage the original materials. Absorbent tissues adhered to and lifted original paint layer while sponges introduced a damaging degree of mechanical action.
- No system could be developed for the successful removal of the less soluble graffiti material from the painting.
- The proprietary graffiti removal product tested, Graffiti Gold Remover™ (104-T.13), was found to remove the more soluble graffiti almost completely in one small area, however the removal was rather inhomogeneous, uncontrollable, and damaging to both coating and original materials (Figures 10.67 to 10.70).

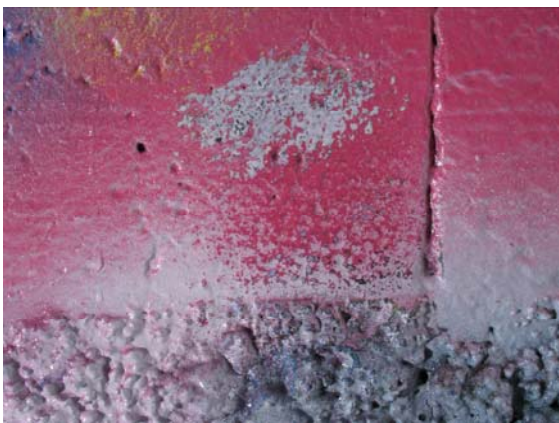
Figure 10.68 (above): Results of cleaning trial 104-T.13. The results are extremely poor in comparison to the results achieved with the developed system in cleaning trial 104-T.21. **Photo: Courtauld Institute CWPD 2007**

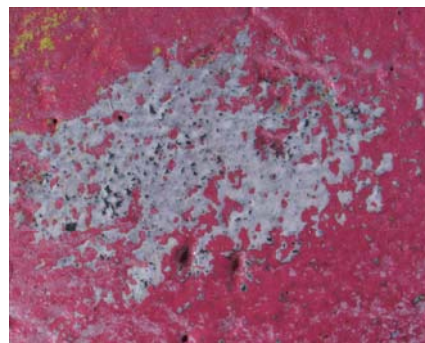
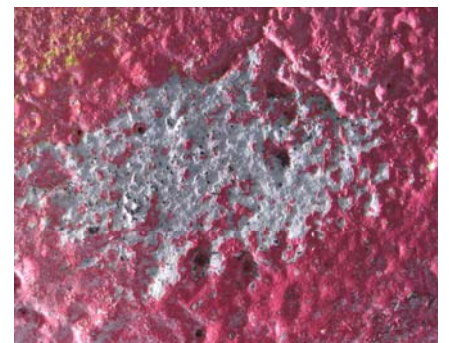
Figures 10.69 (above left) and 10.70 (above right): Details of cleaning trial 104-T.13 in normal (left) and raking light (right). Removal of the graffiti paint is limited and results are inhomogeneous. Furthermore, the original paint layer has been visibly damaged and worn away in areas. **Photo: Courtauld Institute CWPD 2007**

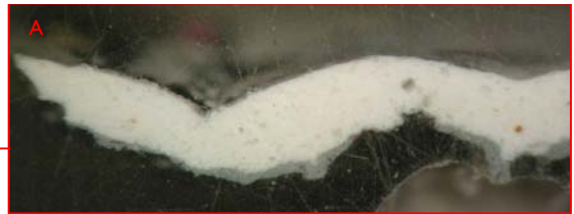
Figure 10.72: CWPD x-section 3893, photographed at 100x. Photomicrograph: Courtauld Institute CWPD 2007

Cross-section microscopy (Figures 10.71 to 10.77):

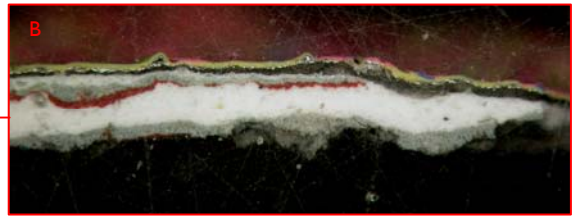
Figure 10.73: CWPD x-section 3894, photographed at 100x. Photomicrograph: Courtauld Institute CWPD 2007

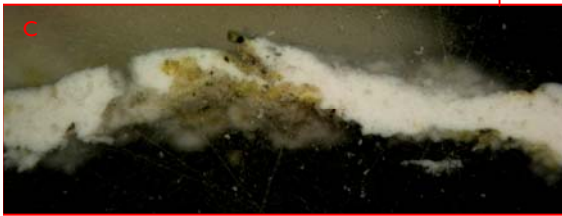
Figure 10.74: CWPD x-section 3895, photographed at 100x. Photomicrograph: Courtauld Institute CWPD 2007

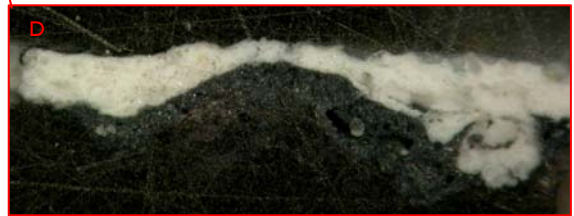
Figure 10.75: CWPD x-section 4082, photographed at 100x. Photomicrograph: Courtauld Institute CWPD 2007

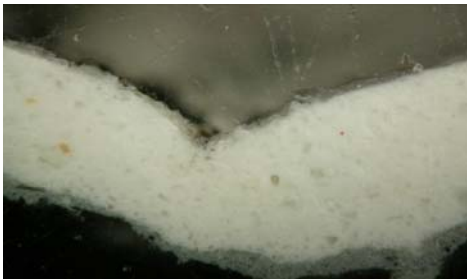
X-section 3893, 200x; under normal (top) and UV (bottom) lights.

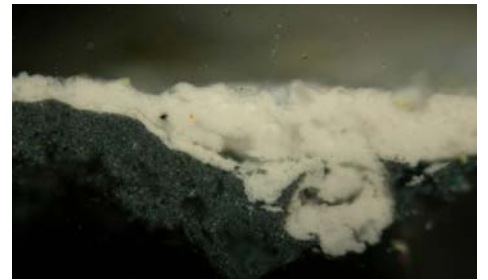
X-section 4082, 200x; under normal (top) and UV (bottom) lights.

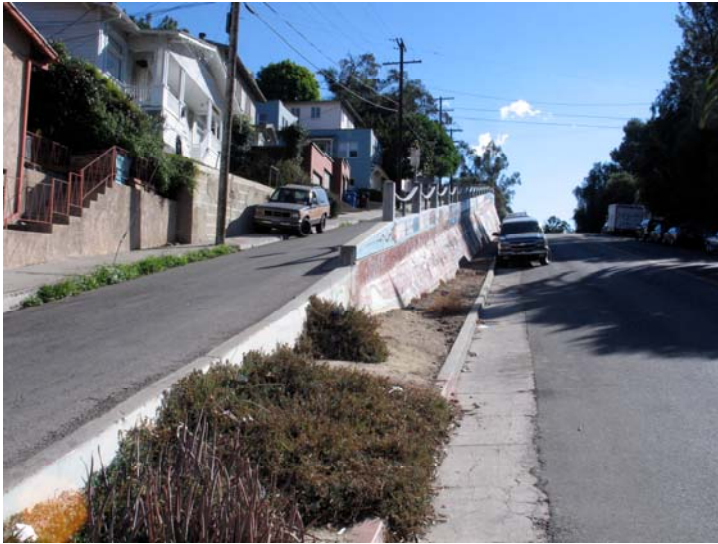
Figure 10.84: *Untitled mural by Janet Sellers, James Garcia, and local youth; 1985, in Elysian Park located on either side of the Academy Road park entrance, Los Angeles, California. View of north wall. Photo: Courtauld Institute CWPD 2007*

<p>Physical Context: The painting is located on two retaining walls situated on either side of the Academy Road entrance to Elysian park (Figures 10.84 and 10.85). The property is under the jurisdiction of LA City Department of Parks and Recreation (Appendices 4.4.2 and 4.4.4).</p>	
<p>Significance: The untitled mural, although designed by professional artists, was painted by 35 local youth and rival gang members (Dunitz 1993: 104). It is significant for its representation of Hispanic and Chicano history and is an important icon to the community in which it is situated.</p>

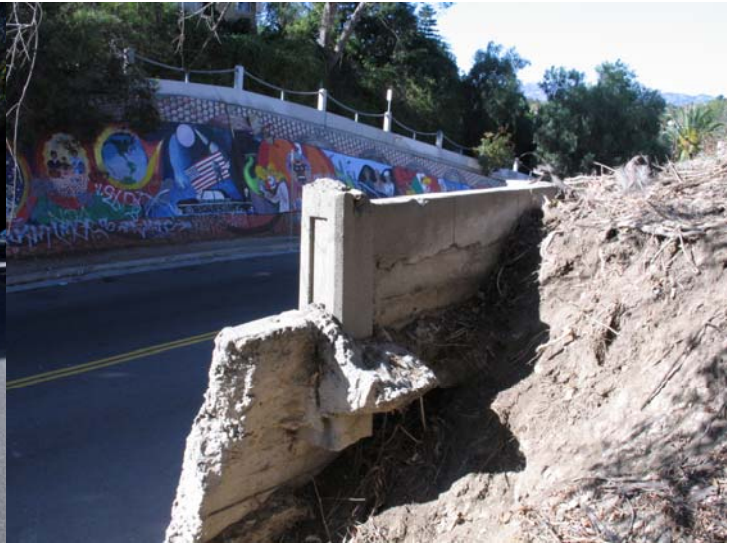
Figure 10.85: *Elysian Park mural. View of south wall and reverse side of north wall. Photo: Courtauld Institute CWPD 2007*

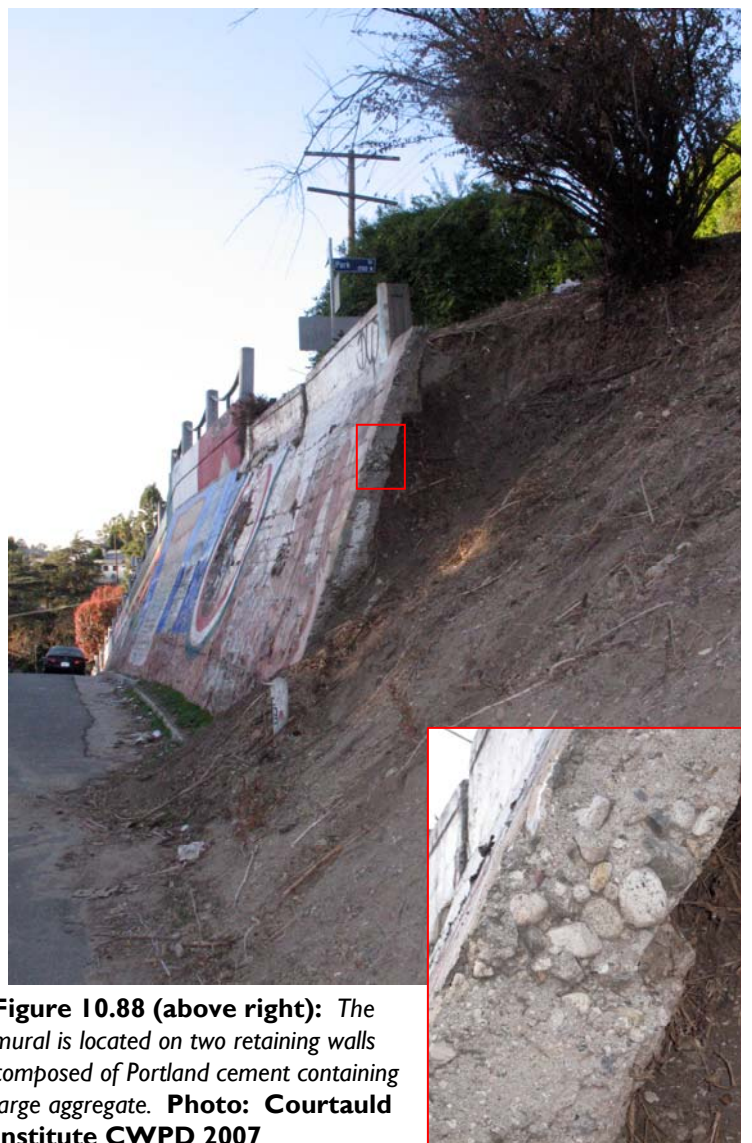
Figure 10.88 (above right): *The mural is located on two retaining walls composed of Portland cement containing large aggregate. Photo: Courtauld Institute CWPD 2007*

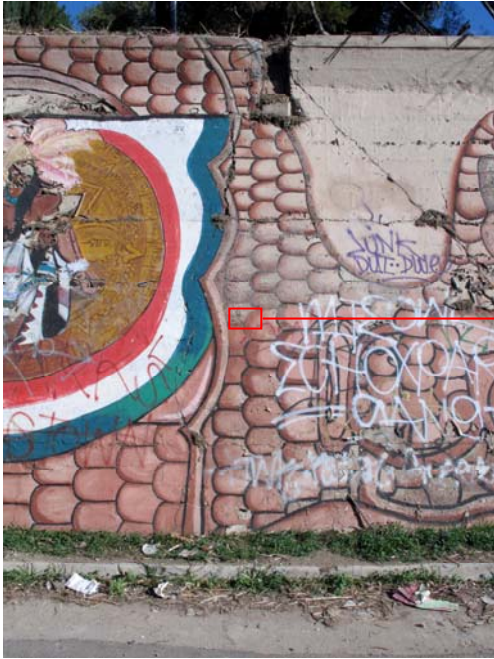
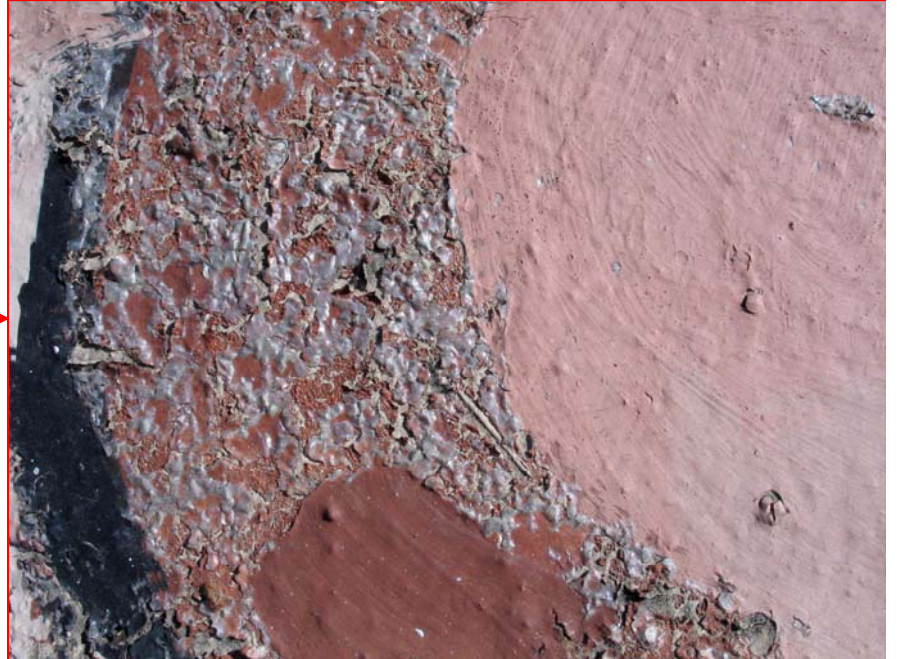
Figures 10.89 (above left) and 10.90 (above right): Detail; north wall. Cracking and flaking of the original paint layer. **Photo: Courtauld Institute CWPD 2007**

<p>Condition: The mural suffers from serious delamination or loss of adhesion to the support (Figure 10.93). Areas of severe flaking and peeling are apparent (Figures 10.89 to 10.92). The overall condition is poor however locations also exist where the paint layer is extremely sound although slightly weakened due to years of exposure to direct sun and other environmental elements (Appendix 4.4.3).</p>	
<p>Added Materials: The painting is reported to have an acrylic coating (Appendix 4.4.9). However, very little evidence of the coating is visible and its original extent is unknown. Furthermore, the mural was at least partially restored in 1991 (Dunitz 1993: 104) during which extensive repainting was likely undertaken after the application of the coating. The mural is currently plagued by the presence of extensive aerosol graffiti.</p>	
<p>Available Documentation: LA City Cultural Affairs Department report (Appendix 4.4.) and contact was made with the artist (J. Sellers).</p>

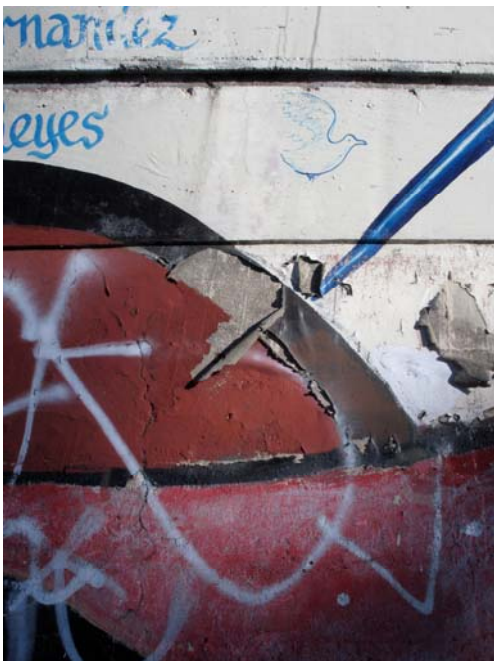
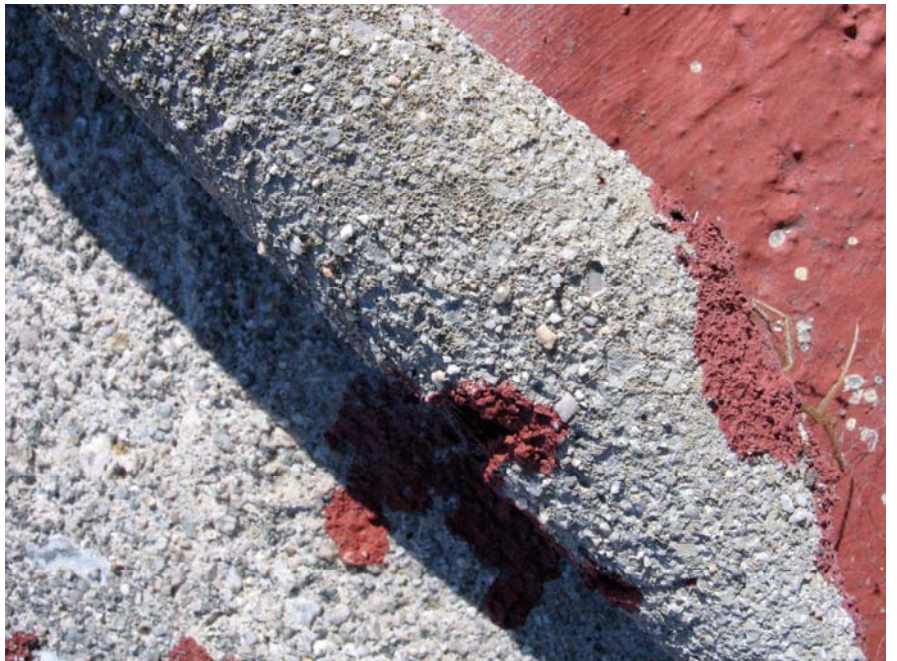
Figures 10.91 (above left) and 10.92 (above right): Detail; north wall. Severe curling of the original paint and preparatory layers. **Photo: Courtauld Institute CWPD 2007**

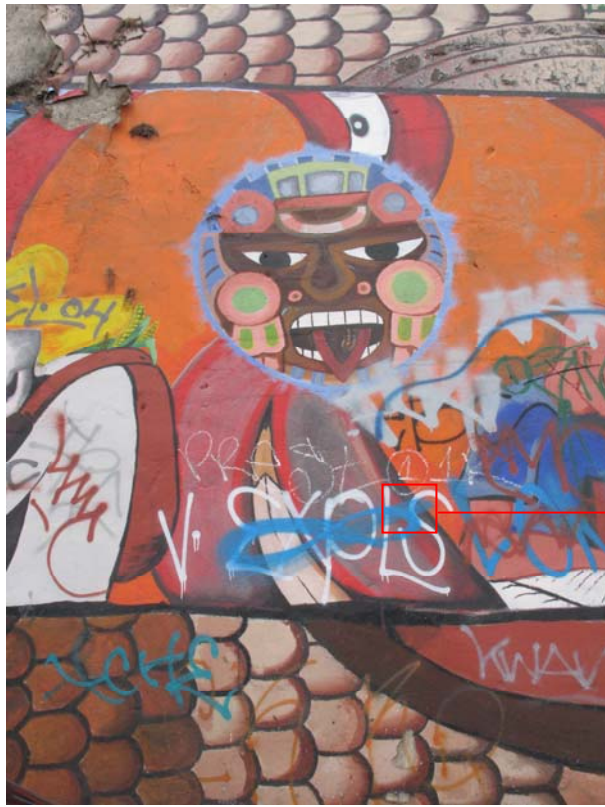
Figure 10.94 (left): Site of successful cleaning trial, 105-T.12. **Photo:** Courtauld Institute CWPD 2007

Cleaning System		Pros.	Cons.
Cleaning System 1 - Trial 104-T.12 (Figures 10.94 to 10.99)			
Application	Carbogel 3% MPA:Stoddard Solvent:NMP (7:7:1) (5 min.)	- Complete removal of graffiti with only slight ghosting in a few areas - Very little damage to the original paint layer observed overall, although some original pigments proved weaker than others	- Time consuming - Only applicable to more soluble graffiti materials - Cleaning system mobilized original paint layer where layer was particularly weak.
Clearance	Swabbing with MPA:Stoddard Solvent (1:1)	- Excellent results particularly since mural was un-coated

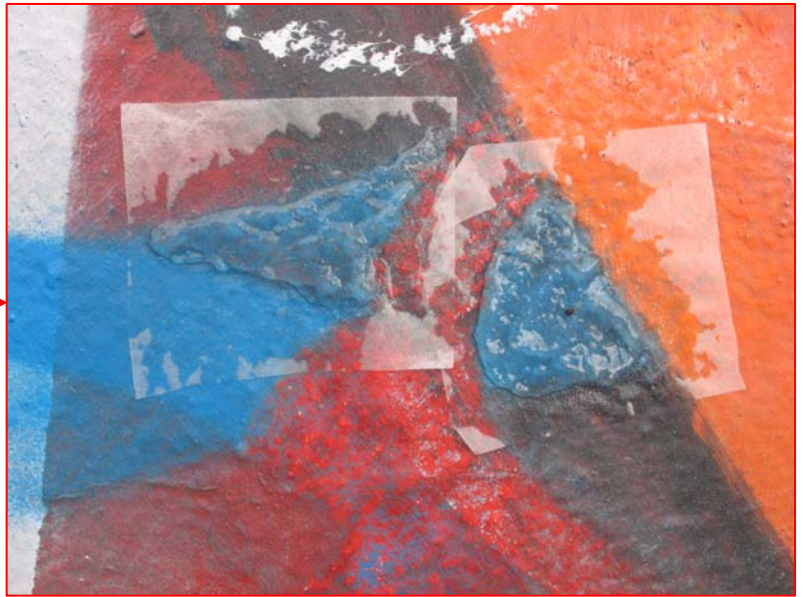
Figure 10.95 (above right): Cleaning trial 105-T.12 was carried out with the application of a solvent mixture in Carbogel 3%. The system was applied to the mural surface in small sections which were easily conformed to the thin strips of aerosol paint encountered. The small sections also helped to control evaporation of the solvent from the graffiti paint during clearance so the added materials could be adequately removed by swabbing with free solvent before re-coalescence of the graffiti paint film occurred. **Photo:** Courtauld Institute CWPD 2007

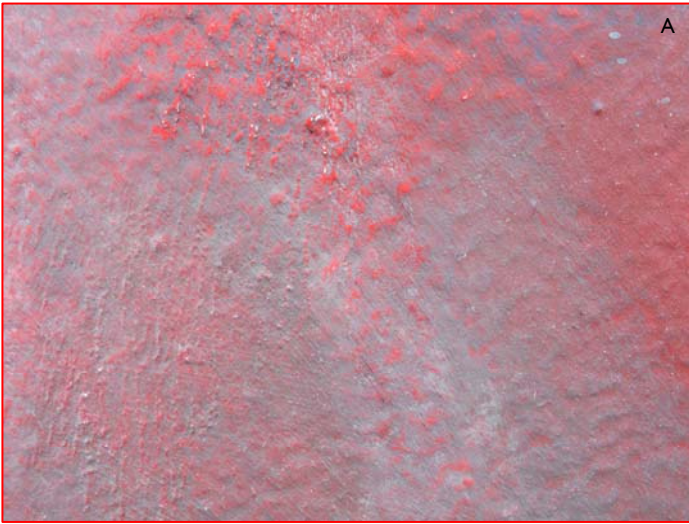
Figures 10.98 (above left) and 10.99 (above right): Details of trial site post-cleaning. Some areas of original paint layer were unaffected by cleaning (left) while in weaker areas, a small amount of ghosting remains and some original pigment was removed (right).
Photo: Courtauld Institute CWPD 2007

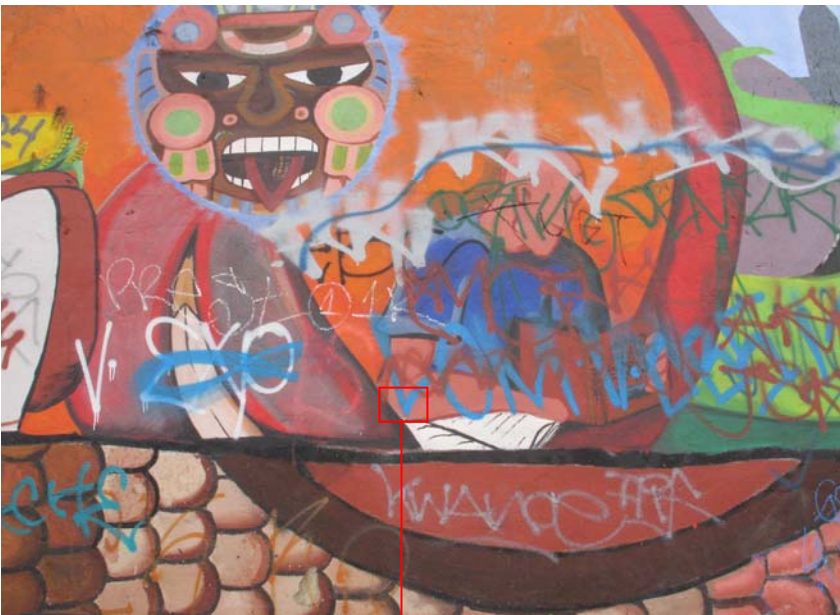
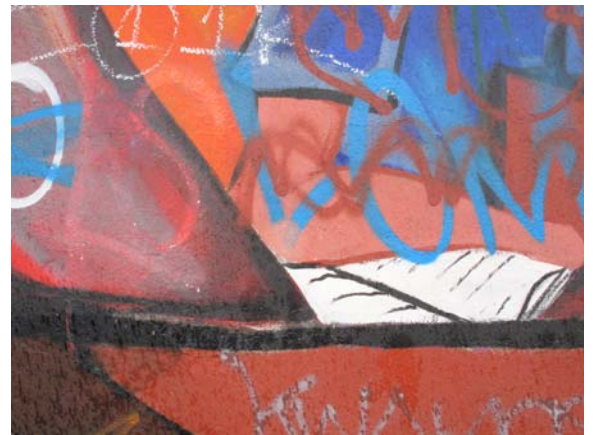
Figure 10.101 (above): Site of cleaning trial105-T.13, post-cleaning. **Photo: Courtauld Institute CWPD 2007**

Figure 10.100 (above): Site of cleaning trial105-T.13. The proprietary product, Mötsenböcker's Lift Off 4 ®, was tested for the removal of graffiti paint. **Photo: Courtauld Institute CWPD 2007**

- Since the applied sorbents failed to absorb the swollen graffiti paint layers, swabbing was the only clearance method found which would remove the dirt but was delicate enough that it wouldn't damage the original materials. Absorbent tissues adhered to and lifted original paint layer while sponges introduced a damaging degree of mechanical action.
- No system could be developed for the successful removal of the less soluble graffiti material from the painting.
- The proprietary graffiti removal product tested, Mötsenböcker's Lift Off 4 ® (105-T.13), was rather ineffective on the graffiti material, but severely damaging to the original paint layer (Figures 10.100 to 10.103).

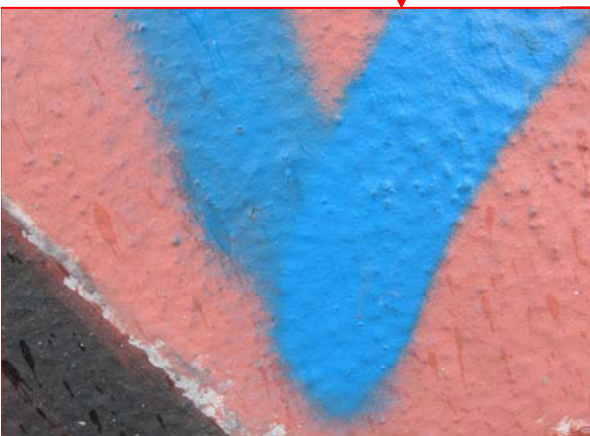
Figure 10.102 (above): Site of cleaning trial105-T.13, pre-cleaning. **Photo: Courtauld Institute CWPD 2007**

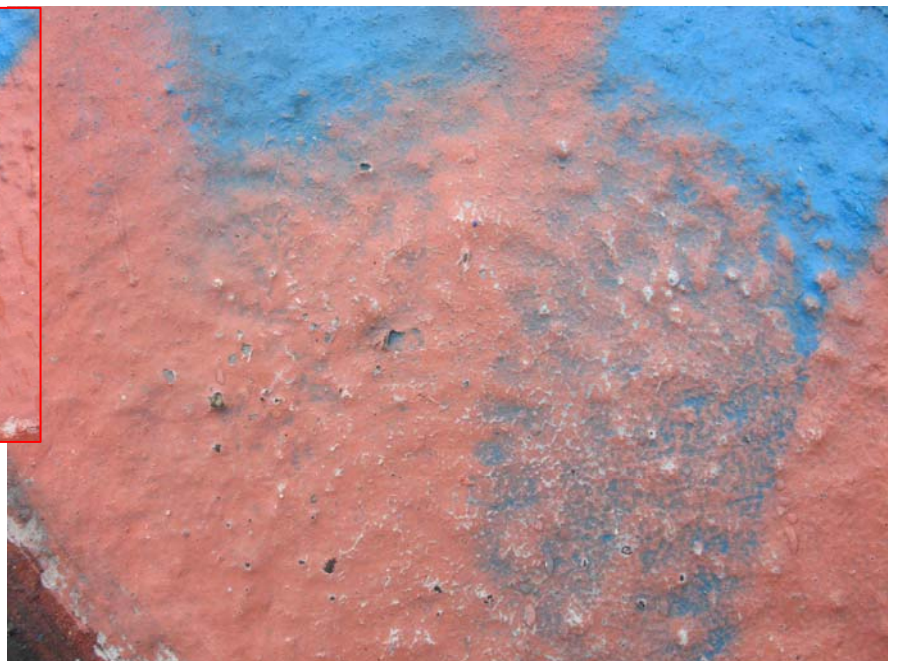
Figure 10.103 (above right): Site of cleaning trial105-T.13, post-cleaning. The proprietary graffiti removal product was unable to successfully remove all aerosol paint and visibly damaged the mural by causing mobilization and cracking of the original paint layer. **Photo: Courtauld Institute CWPD 2007**

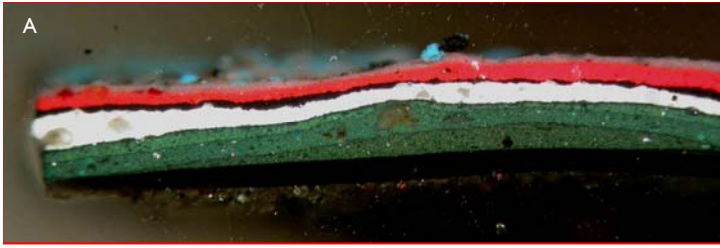
Figure 10.105: CWPDP x-section 4083, photographed at 100x. Photomicrograph: Courtauld Institute CWPDP 2007

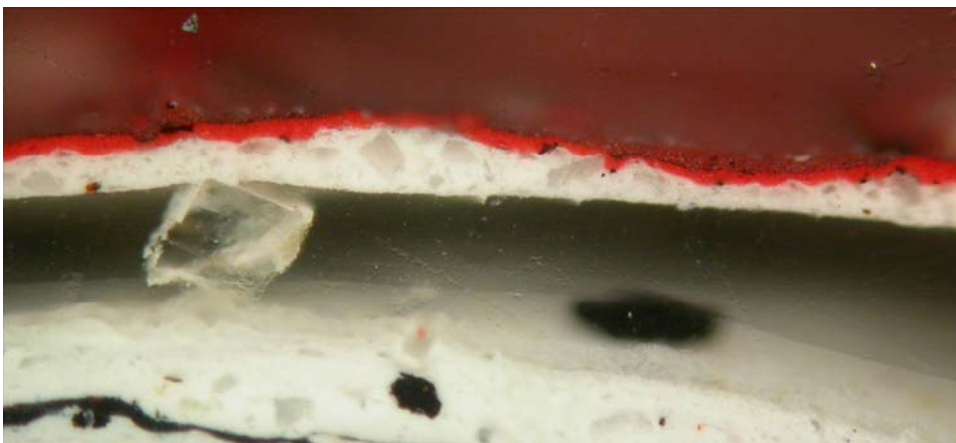
Figure 10.110: X-section 4086, photographed at 200x. Based on its location, the cleaned sample should have a thin black paint layer across its surface. Mobilization of this layer was observed during cleaning however and only slight traces of the layer are visible in the cross-section taken from this area. Photomicrograph: Courtauld Institute CWPDP 2007

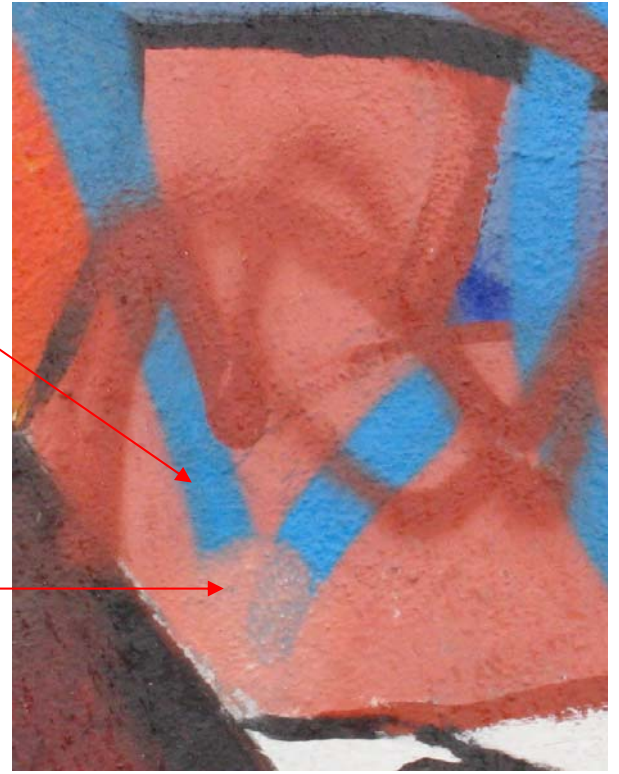
Figure 10.111: Sample locations for the evaluation of cleaning trial 105-T.13. (A) Control sample – uncleaned, no graffiti; (B) Area damaged by cleaning with proprietary graffiti removal product, Mötsenböcker's Lift Off 4®. **Photo:** Courtauld Institute CWPD 2007

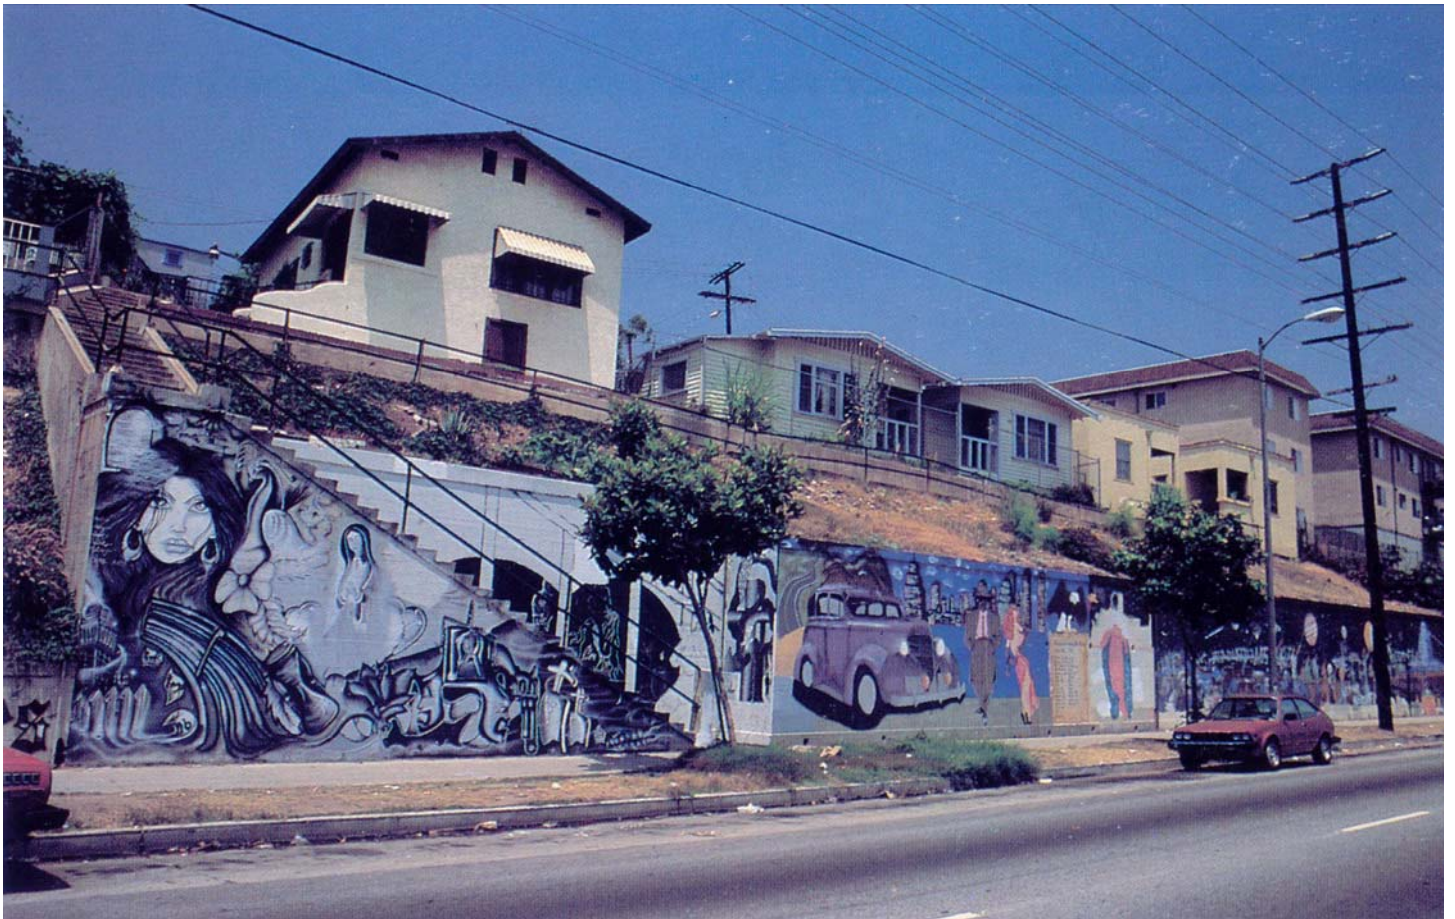
Figure 10.122: *Untitled mural by Peter Quezada, 1990, located on the 3400 block of North Figueroa St. in Highland Park, Los Angeles, California. The mural is shown here as it originally appeared. Quezada's mural includes two monochrome scenes on the far left of the substrate wall and the adjacent cartoon scene. Photo: R. Dunitz 1993.*

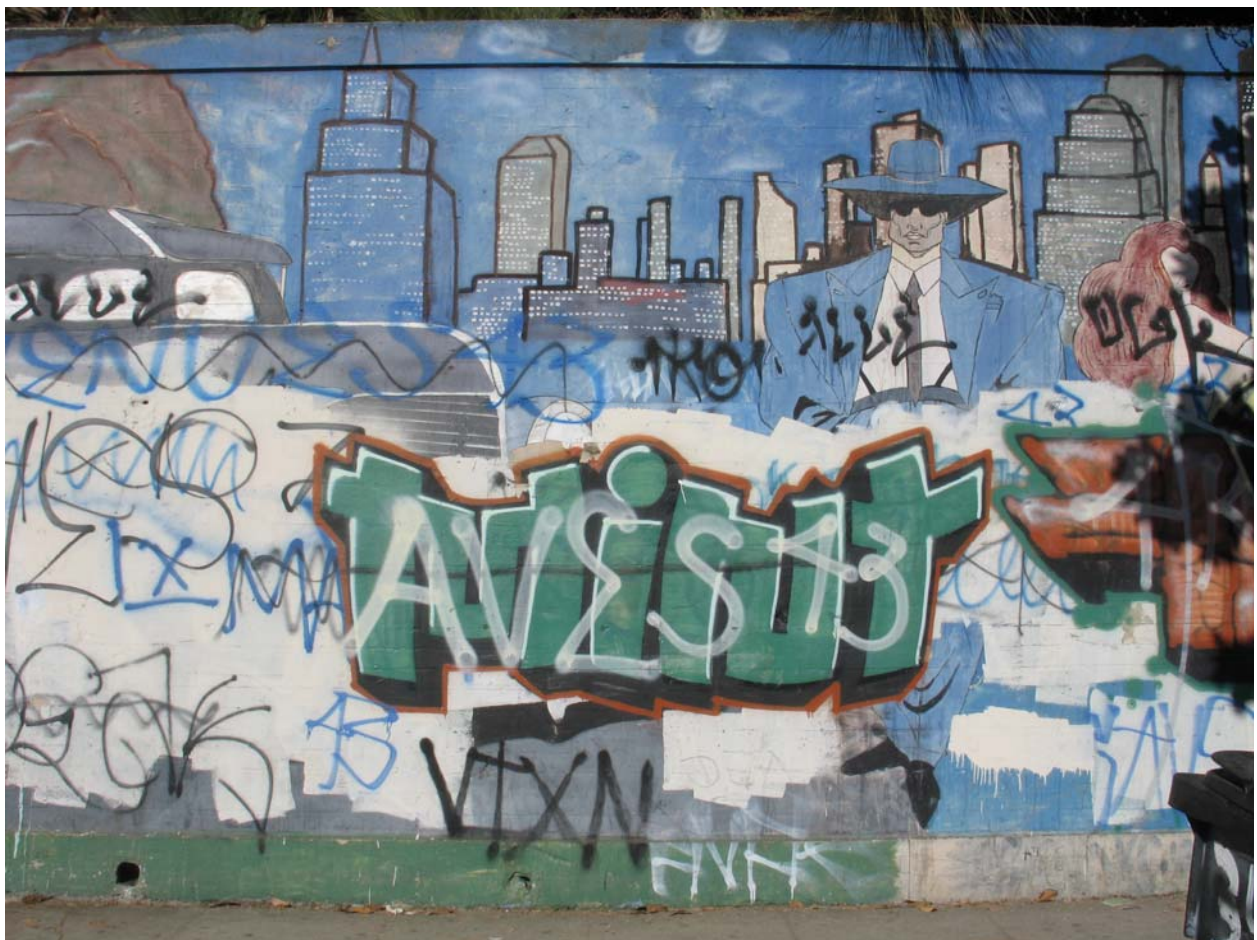
Figure 10.123: *Image of the mural as it appears today. It is covered to a large extent by graffiti paint, much of which has been painted out with a solid layer of white paint only to be re-tagged. Photo: Courtauld Institute CWPD 2007*

No cleaning system was developed which could be successfully implemented to remove the graffiti on Quezada's mural at 3400 North Figueroa Street. The graffiti were insufficiently mobilized by all solvent and sorbent cleaning systems tested (Figures 10.130 to 10.136). Furthermore, the original paint materials themselves were found to be particularly weak and susceptible to all available cleaning methods (see Appendix 4.5.6). This is likely because the original paint materials used were probably low quality and the mural faces in a southerly direction, where it is exposed to maximum levels of direct sun and UV rays.

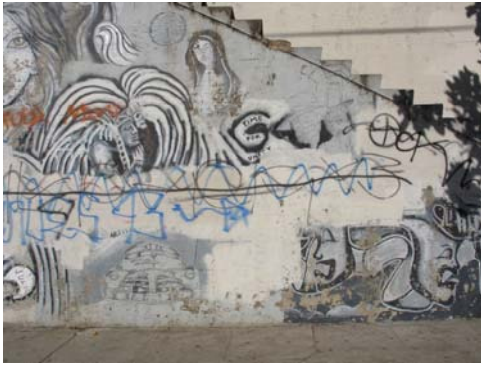
Figures 10.124 (above) and 10.125 (right): The monochrome section of the mural is in terrible condition today. Half of it has been obliterated entirely while the other half is cracking, peeling, and flaking heavily. **Photo: Courtauld Institute CWPD 2007**

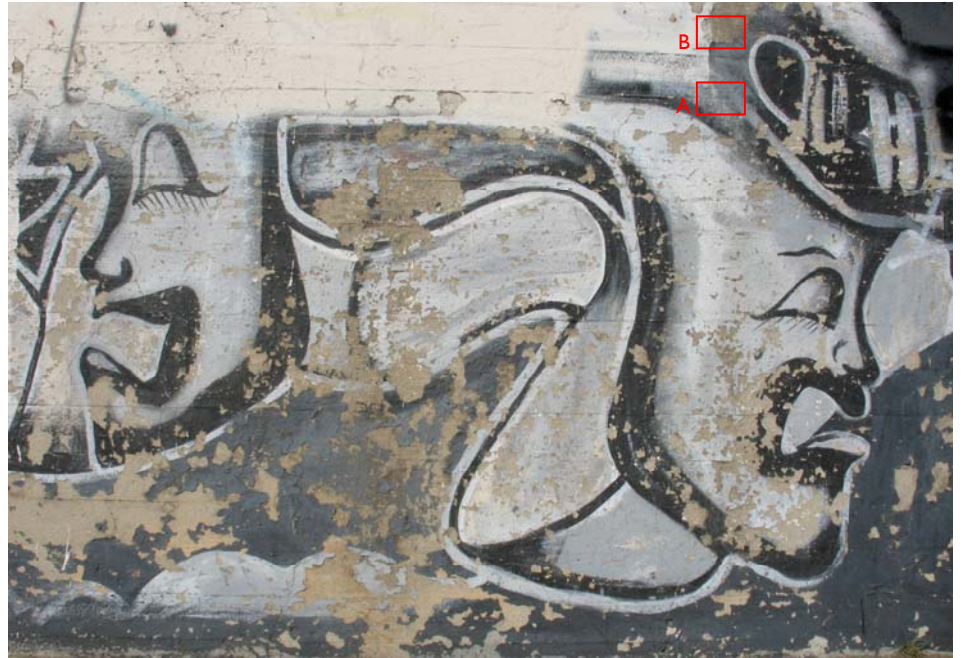
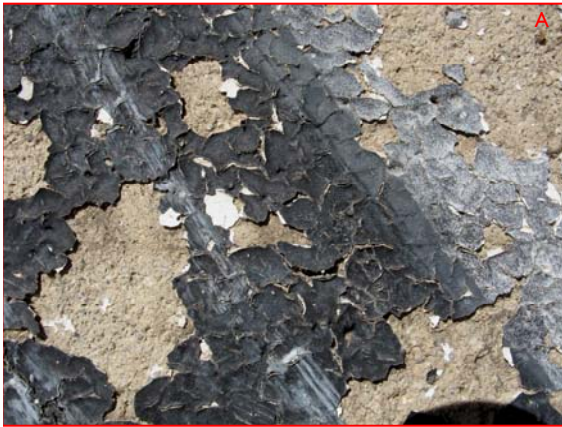
Figure 10.126: Detail; extensive cracking and loss of the original paint layer has exposed the cement support surface and evidence of the white preparatory paint layer applied to the support surface prior to painting. **Photo: Courtauld Institute CWPD 2007**

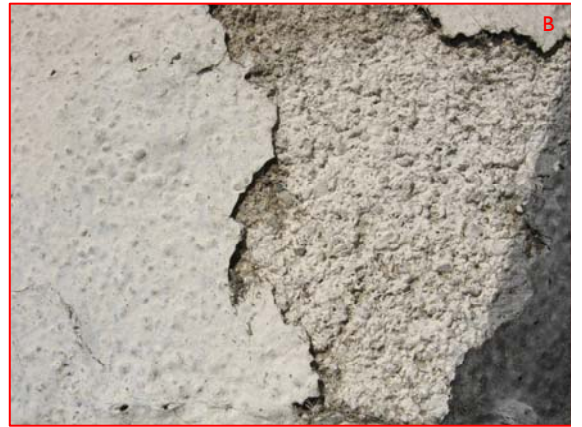
Figure 10.127: Detail; a layer of opaque white paint has been painted over much of the mural's surface to hide existent graffiti marks. **Photo: Courtauld Institute CWPD 2007**

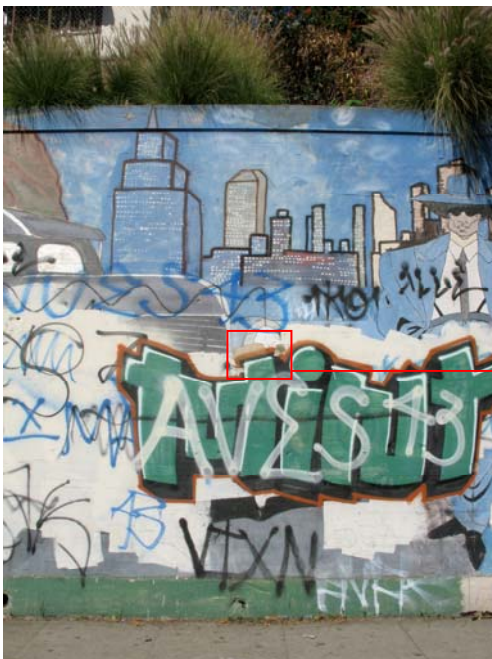
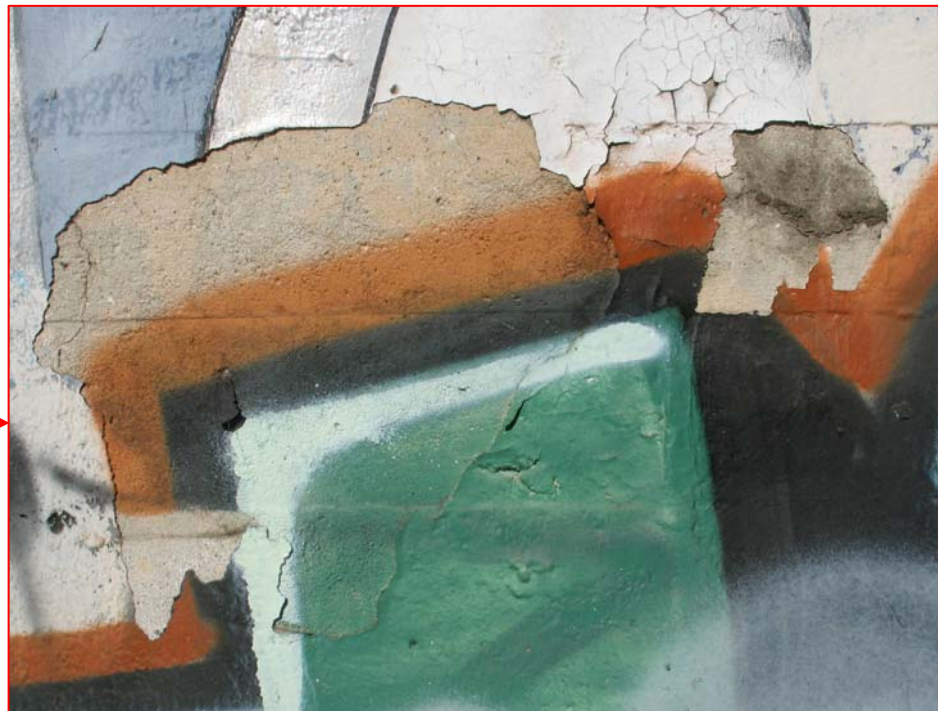
Figures 10.128 (above left) and 10.129 (above right): Although in strikingly better overall condition than the monochrome images, the cartoon images of the original mural do exhibit some deterioration phenomena such as cracking, flaking, and loss. **Photo: Courtauld Institute CWPD 2007**

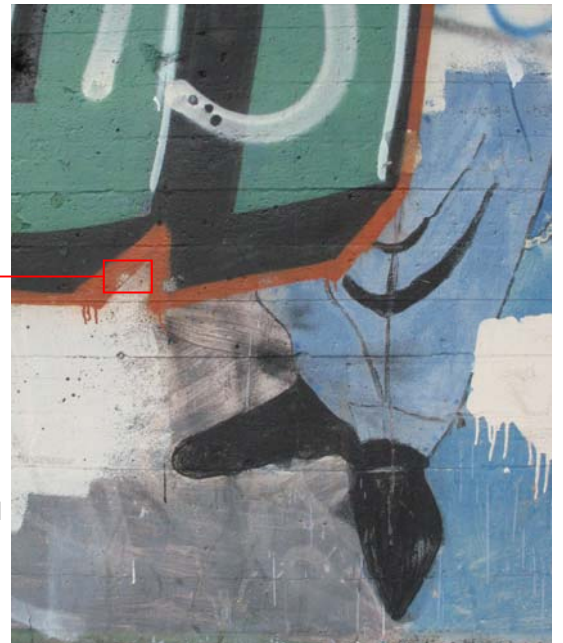
Figure 10.130 (above): Site of the most successful cleaning trial (106-T.04) on the less soluble aerosol graffiti paint. **Photo: Courtauld Institute CWPD 2007**

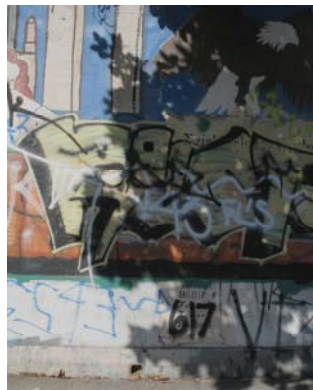
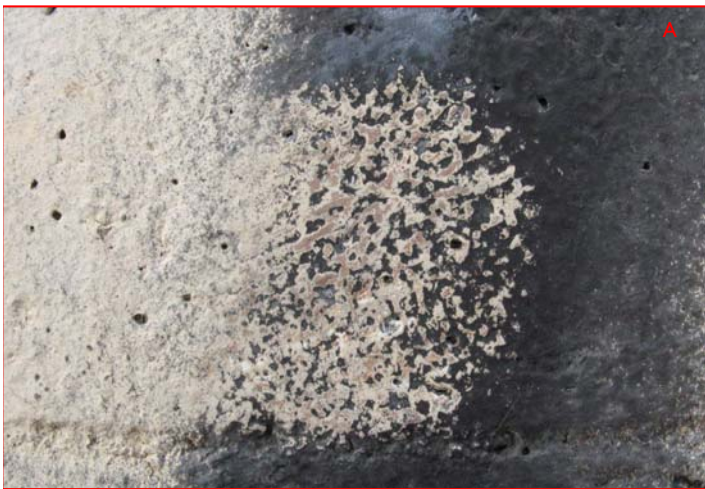
Figure 10.132 (right): Context image showing the site of the final cleaning trials on the more soluble aerosol graffiti paint. **Photo: Courtauld Institute CWPD 2007**

Figure 10.134: Results of cleaning trial 106-T.08. **Photo: Courtauld Institute CWPD 2007**

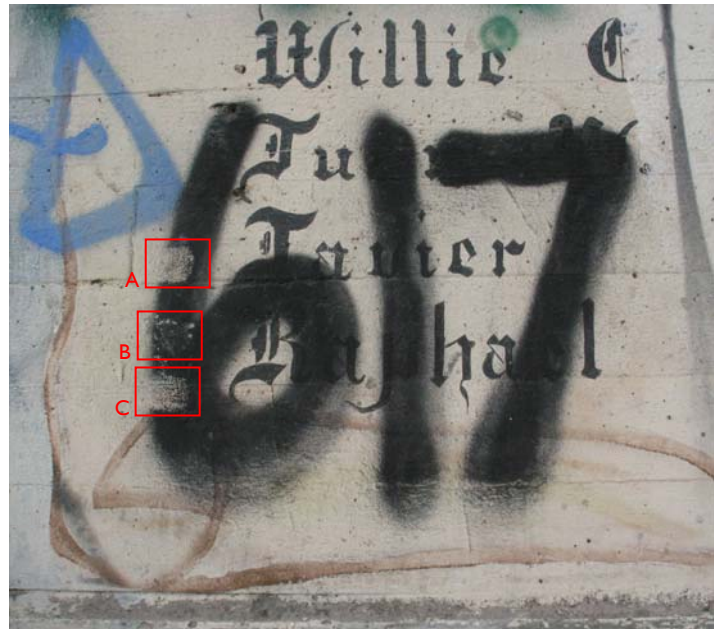
Figure 10.133: Site of final cleaning trials on the more soluble aerosol graffiti paint. **Photo: Courtauld Institute CWPD 2007**

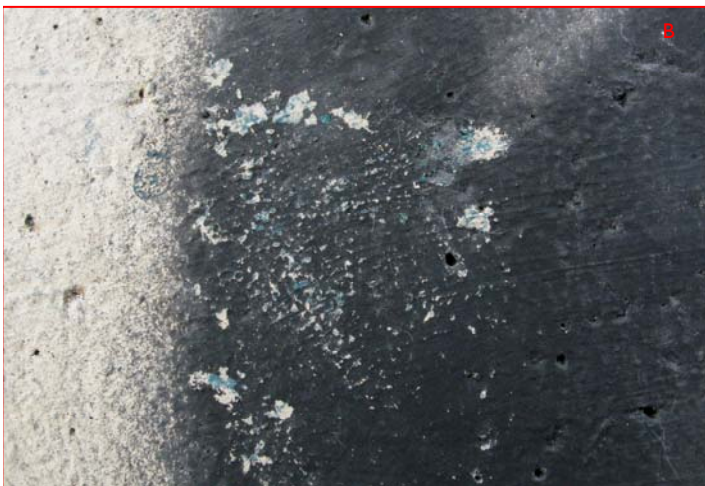
Figure 10.135: Results of cleaning trial 106-T.09. **Photo: Courtauld Institute CWPD 2007**

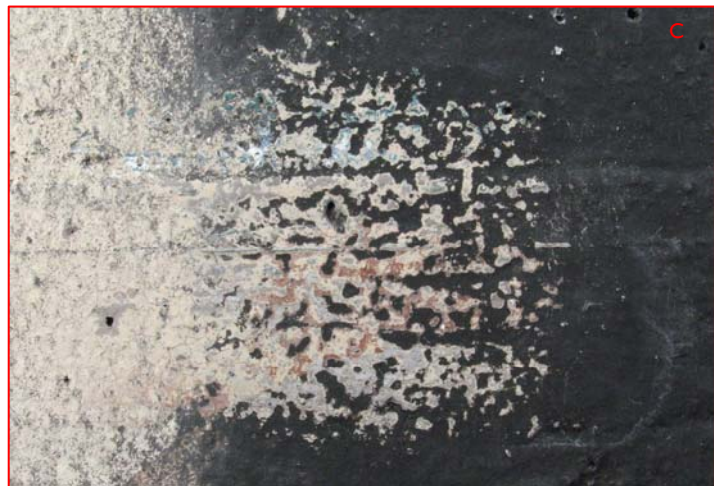
Figure 10.136: Results of cleaning trial 106-T.010. **Photo: Courtauld Institute CWPD 2007**

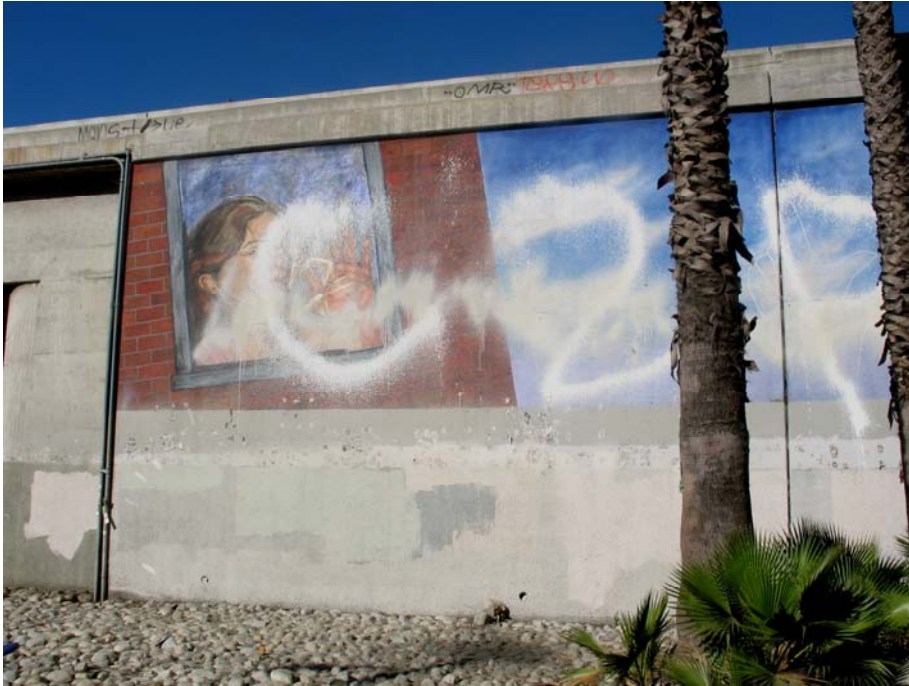
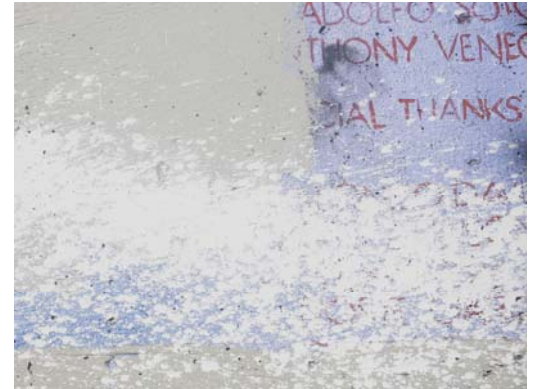
Figures 11.1 – 11.4: New and inventive methods of graffiti paint application are continuously evolving. For example, liquid paint applied to the wall with a ‘Super Soaker’ water gun is now commonplace, meaning that graffiti can be accurately shot onto a surface from up to twelve meters away.

Figure 11.2: Detail of Figure 11.1 depicting the splattered liquid paint across the mural's surface. **Photo: Courtauld Institute CWPD 2006.**

Figure 11.1: ‘Silent Prison’ by Margaret Garcia and five deaf youth, 1984, 8th St. on-ramp to the 110 freeway north in Downtown Los Angeles, California. Today graffiti paint, which has been applied by a high-pressure water gun can be seen scrawled across the mural's surface; however, because the mural has been executed at more than six feet above ground level, graffiti would not have marred its surface in the past. **Photo: Courtauld Institute CWPD 2006.**
