M.A. Dissertation 2007

Conservation of Wall Painting Dept.

Courtauld Institute of Art

An Investigation of Chemical Methods for the Removal of Aerosol Graffiti Paint from Contemporary, Exterior Mural Paintings

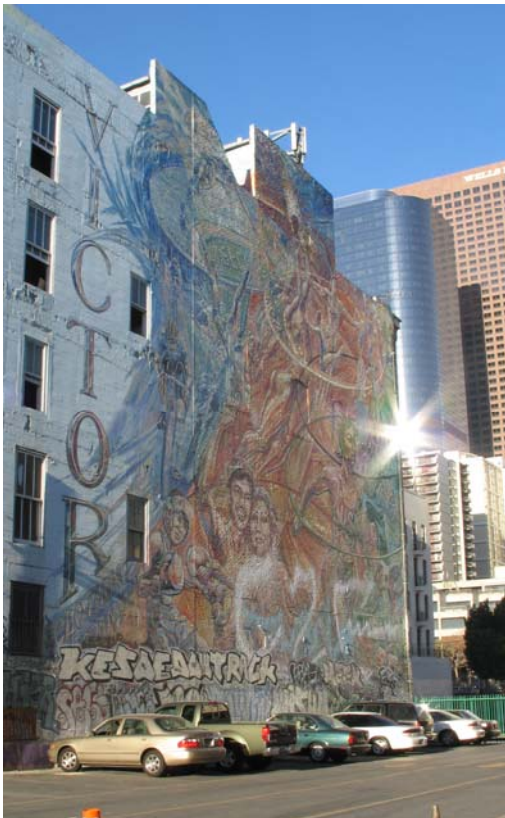
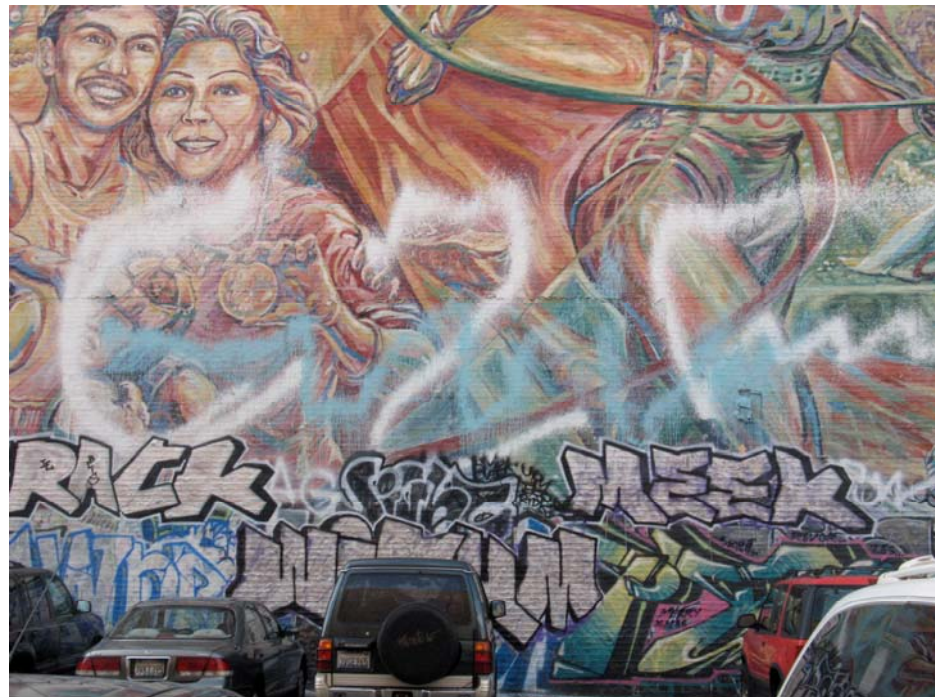
Figures 11.1 – 11.4: New and inventive methods of graffiti paint application are continuously evolving. For example, liquid paint applied to the wall with a ‘Super Soaker’ water gun is now commonplace, meaning that graffiti can be accurately shot onto a surface from up to twelve meters away.

Figures 11.3 (above left) and 11.4 (above right): ‘El Nuevo Fuego (The New Fire)’ by East Los Streetscapers, 1985, exterior wall of the Victor Clothing Co. Building, 240 S. Broadway St. in Downtown Los Angeles, California. Graffiti paint applied with a water gun occurs here high above the vast majority of graffiti applied to this mural by hand with aerosol spray paint. **Photo: Courtauld Institute CWPD 2007.**
