# Conserving a boundary: The conservation and management of a Berlin Wall mural

In 1991, five segments of the Berlin Wall, first painted by renowned contemporary artists Thierry Noir and Kiddy Citny, were bought at auction, transported to the USA, and placed in an outdoor environment that severely advanced the deterioration of the painted surface and reinforced concrete substrate. This paper discusses aspects of the conservation treatment and management plan for these painted segments of the Berlin Wall. The strategy and criteria for the conservation program were defined by a multidisciplinary team that comprised conservators, concrete specialists, and engineers; the deliberations of this team also led to an appropriate treatment and management plan. The choice to intervene at a minimal level meant treatment was restricted to stabilization rather than restoration or reconstruction of deteriorated areas. Additionally, the team decided to reinstall the pieces indoors to reduce future deterioration.

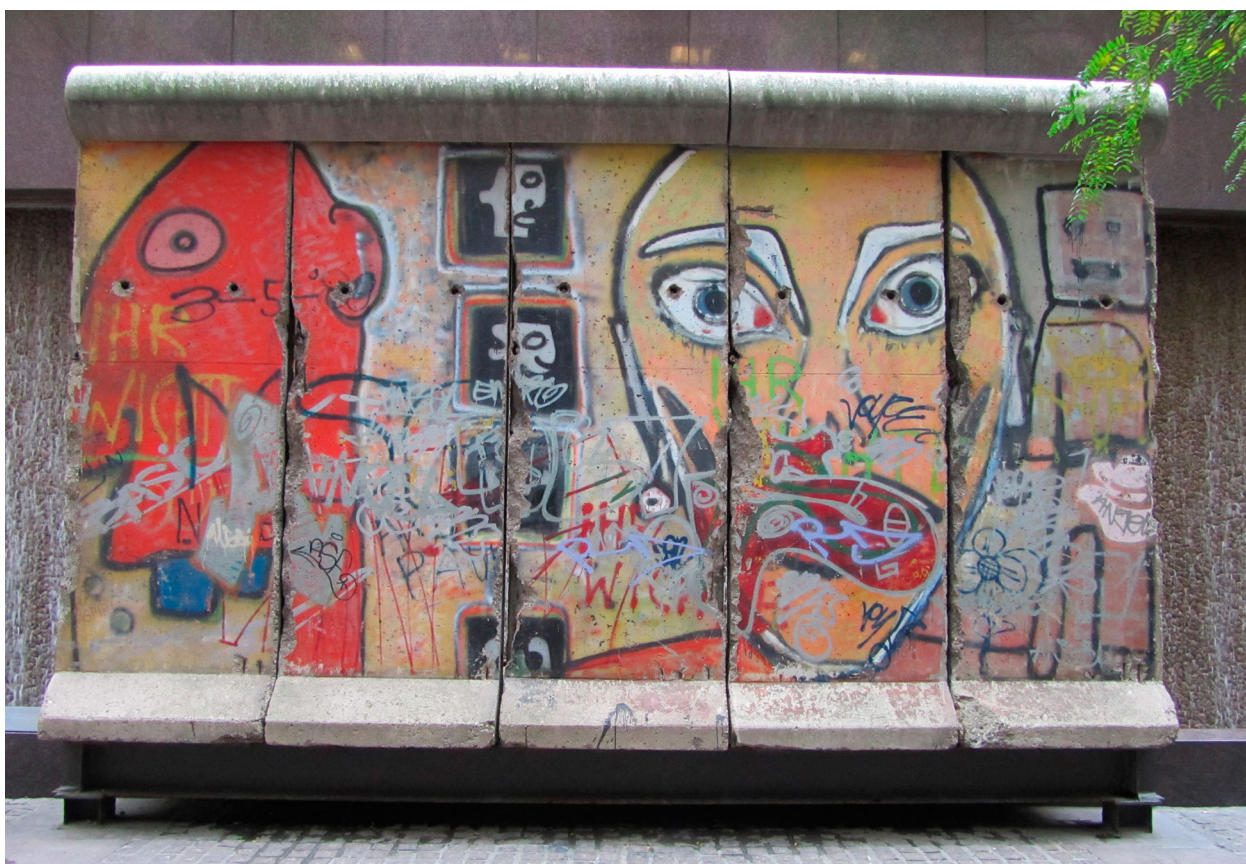
**Figure 1** An image of the segment installed in its original Manhattan location. The large red head and adjacent 'film strip' of monochrome heads was painted by Thierry Noir. Kiddy Citny painted the yellow head and small figure to its right. Image: © Cranmer Art Group, LLC, 2010.

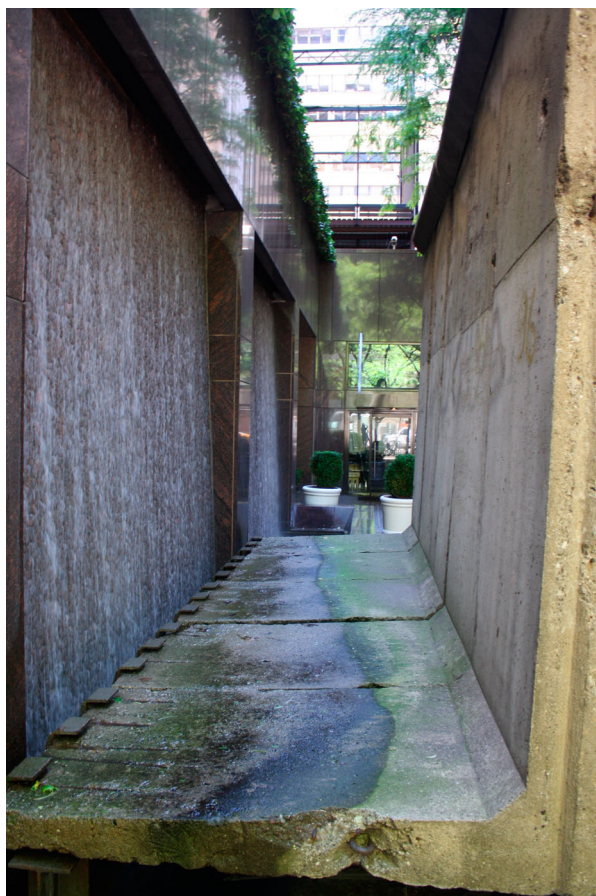
The segments were intentionally placed in a location accessible to the public and, with aesthetics in mind, positioned directly in front of an urban waterfall. Water fell directly on the foot, spraying the rear and creating a humid atmosphere around the base (Fig. 2). Wetting and drying cycles induced by the water feature, in conjunction with Manhattan's harsh outdoor environment, led to severe deterioration of the mural; this included cracking and delamination of the concrete support, corrosion of the internal rebar, and flaking and loss of the paint layers. In 2013, after a succession of large losses of the painted substrate occurred, the need for conservation treatment was recognized by the owner.

**Figure 2** The waterfall that wets the base of the wall, causing biological growth and fully saturating the concrete substrate. Corrosion of rebar and loss of substrate can be seen on the left side of the base. Image: © Kiernan Graves, 2013.

When confronted with the rapidly deteriorating segments of the Berlin Wall, all parties involved agreed that the segments should be removed from the path of the waterfall. However, the remedial treatment procedure, subsequent reinstallation, and future maintenance regime required far greater deliberation to reach an appropriate consensus.

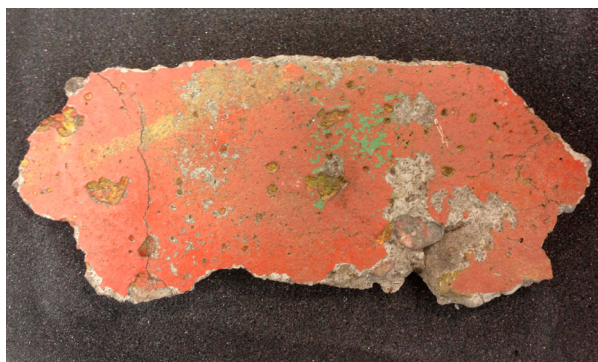
Ultimately, conservation treatment was instigated as a result of two events. First, in early 2013, a large loss occurred in the mural where an internal rebar had corroded and expanded so appreciably that a large piece of painted substrate detached (Fig. 3). This was the second such known incident, but in this case the detached piece was recovered. Second, on 9–10 August 2014, in a well-orchestrated act of vandalism, the words 'IT'S LIKE TALKIN TO A WALL' were spray painted through a stencil across the mural's surface in Arabic, English, and Hebrew (Fig. 4). Although this site offers greater security than most other outdoor murals, the mural's accessibility was one factor enabling the defacement and while this was the most significant incident of vandalism to date, it was not the first.

**Figure 3** A large fragment,  $\sim 75 \times 25$  cm ( $30 \times 10$  inches), that completely detached from the wall and was subsequently recovered by the guards manning the security station inside the adjacent building. Image: © Kiernan Graves, 2013.

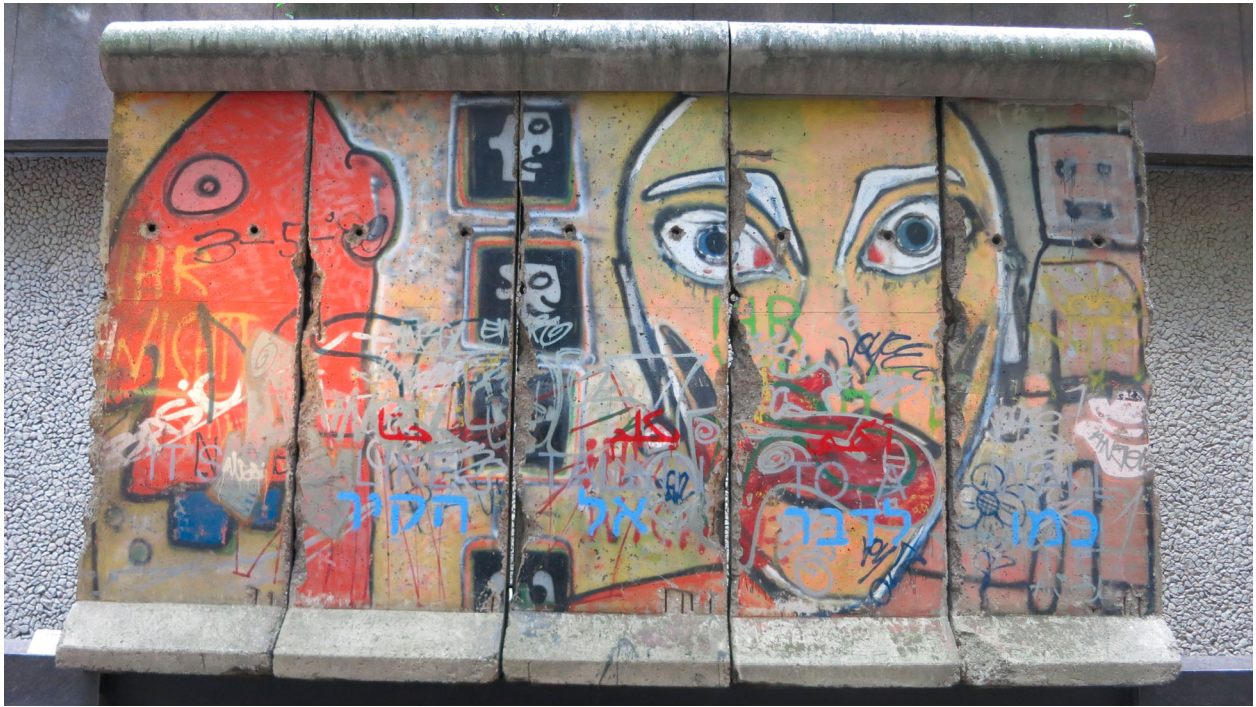
Figure 4 Image of the wall in the courtyard showing the graffiti after the waterfall had been shut off. The area from which the fragment shown in Fig. 3 had detached is seen at the bottom right of the central panel. There are three vertical exposed rebars visible from within the loss. Image: © Tishman Speyer, 2014.

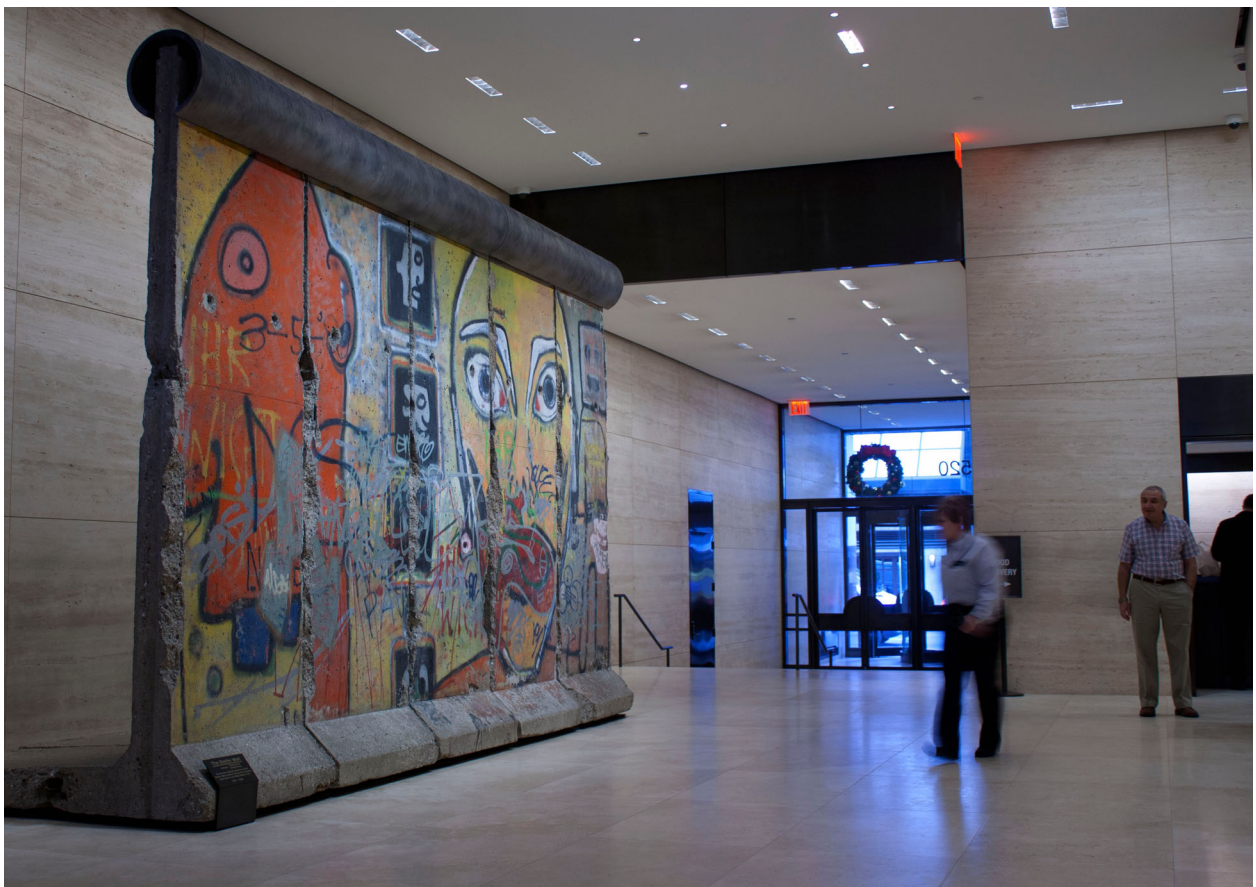
Figure 5 The wall installed in its new location in the lobby of the Madison Avenue office building. Image: © Ellen Davis, 2015.

In order to limit the remedial treatment to a program that emphasized minimal intervention, the team decided to install the segments of the wall in the lobby of the building whose courtyard it had previously occupied (Fig. 5). The environment is controlled for human comfort throughout the year and therefore much more suitable for the segments. The main concern is the possibility of condensation occurring on the rebar during the summer months when air-conditioning is in use. During the summer of 2016, conditions will be monitored to understand if this is indeed a risk and, if so, determine how to moderate the environment to prevent condensation from activating further corrosion.
