Account of an Informed Bat Exclusion at the Temple of Deir el-Shelwit, Luxor, Egypt

The conservation of the painted Roman-era reliefs in the temple of Deir el Shelwit in Luxor, Egypt, was recently initiated by the American Research Center in Egypt (ARCE). As a critical step in a series of preliminary preventive conservation measures undertaken at the temple, a resident bat colony was excluded to control further deterioration of the painted reliefs and stone fabric (Figure 1). In consultation with a bat biologist, a comprehensive humane, low-tech emergency exclusion programme was designed and implemented, which included roost location, behavioural surveys, species identification, sealing of building openings, bat exclusion and the design of an alternate roost site. This programme may serve as a useful example for other conservation projects in Luxor, since it provides much-needed information on the behaviour of local bats, as well as relevant insights gained from the exclusion procedure.

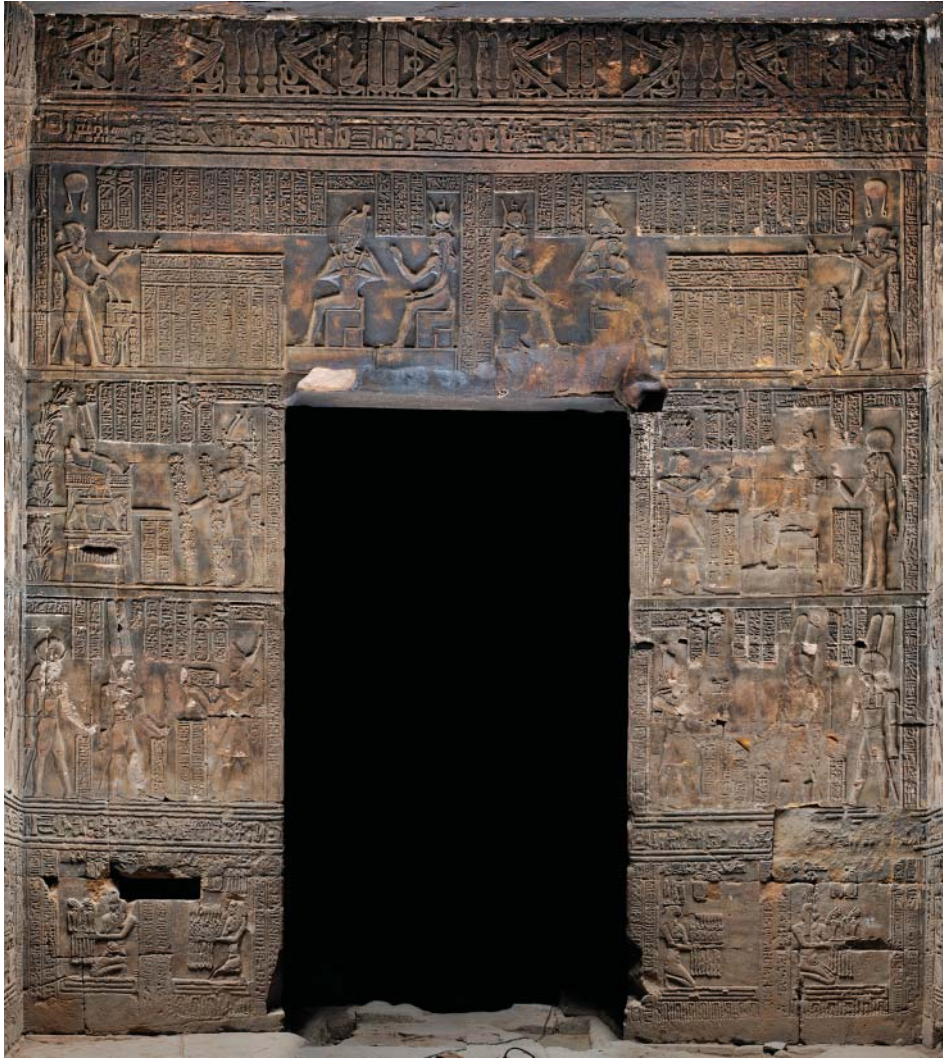
FIGURE 4 Reliefs on the interior east wall of naos.

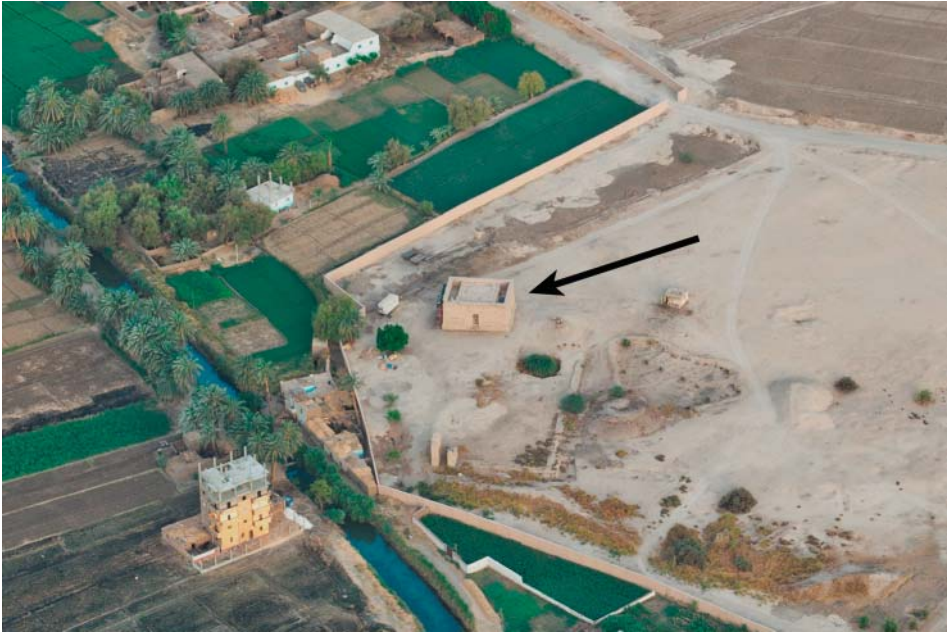
FIGURE 5 Aerial view of Deir el Shelwit, clearly showing its location at the interface between desert and cultivated lands (arrow indicates the temple).

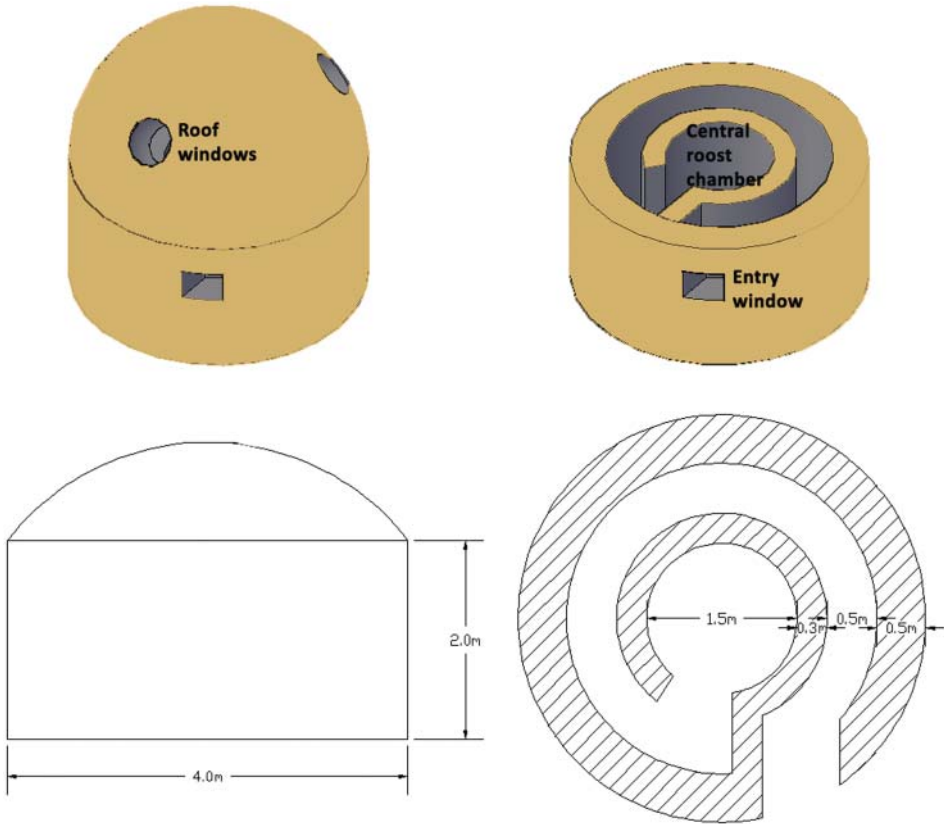
FIGURE 8 Proposed bat house design.

The bat house designed for Deir el-Shelwit will have a long corridor providing access to a high-ceilinged central chamber for roosting (Figure 8). It will be built of adobe (earthen brick), a locally obtained, low-cost material with good insulating properties, which will aesthetically integrate the structure into its surroundings. The design incorporates the following factors:

- thermal insulation: the adobe brick walls will be 0.3–0.5 m thick; the entry corridor wraps around the central chamber to increase insulation, with a double roof serving the same purpose
- air flow: the entry window in the outer wall and smaller windows in both roofs should provide low, but sufficient levels of airflow
- light: the windows will be small and unaligned; thus, no direct light can enter the central roosting chamber
- protection: there will be no openings at ground level, thereby reducing access to the roost by local ground-dwellers, including humans
- location: the house will be built as near as possible to the temple, far from trees, wires, roads, and paths (Figure 9); and
- guano deposition: this is the only unresolved aspect of the house, and it is hoped that either it will be resolved naturally or that periodic cleaning can be undertaken.
